Impact of the Northridge Earthquake on the Garnier Building, Los Encinos State Historic Park

THOMAS A. WINTER[¶]

The subject project is an 1872 two-story stone structure in the San Fernando Valley of Los Angeles, California. The site is on Ventura Boulevard (old Highway 101): west of the 405 Freeway and about 5 miles (8 km) from the Northridge Earthquake epicenter. The property consists of a small site with a core of historic structures that constitute the prime resources of a historic park.

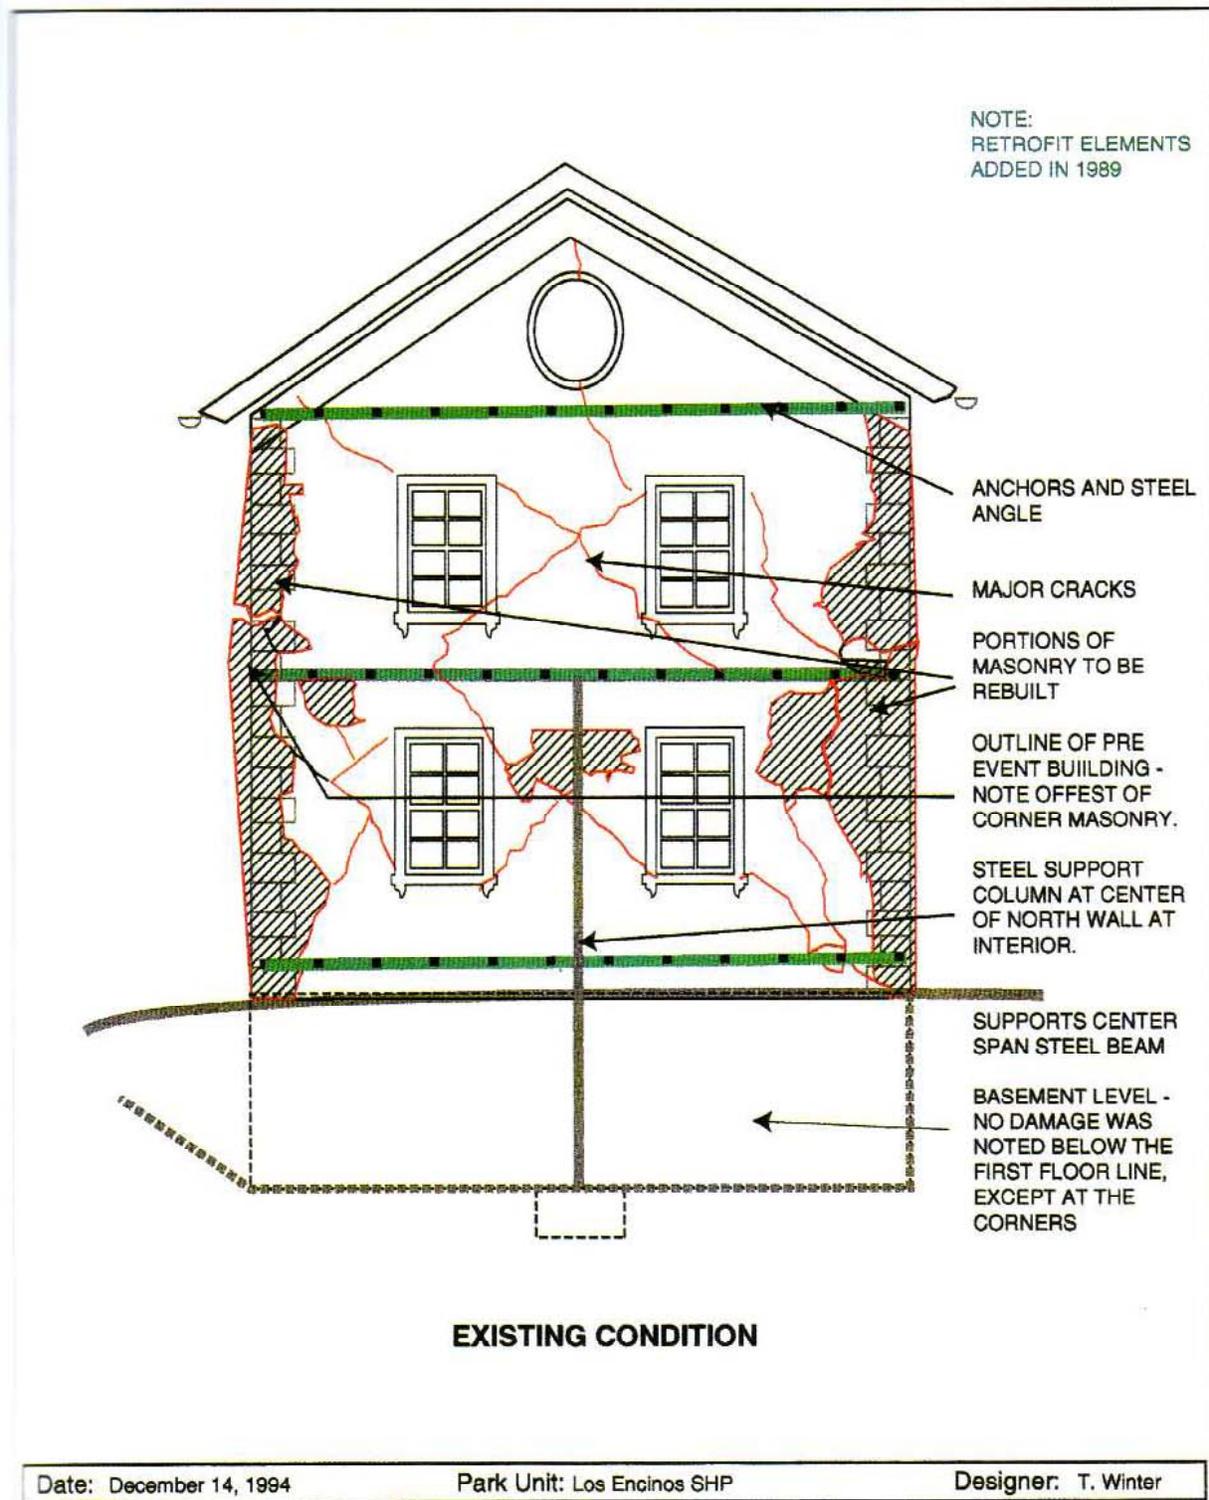
Figure 18.1 Garnier Building: north elevation. Existing condition following Loma Prieta, Dec. 1994. (Drawing: Thomas Winter 1994).

The north elevation suffered severe cracking such that the area between the lower windows collapsed, leaving two small piers of masonry supporting the continuous header over the windows. The building corners, which had no anchors within the width of the wall, dislodged and are immanently in danger of collapse. The lack of corner anchors has been noted as a deficiency and current unreinforced masonry design includes corner anchors. The masonry above the second-floor windows remains in good condition with little cracking. This masonry was tied into the roof and second-floor ceiling structure during the retrofit.

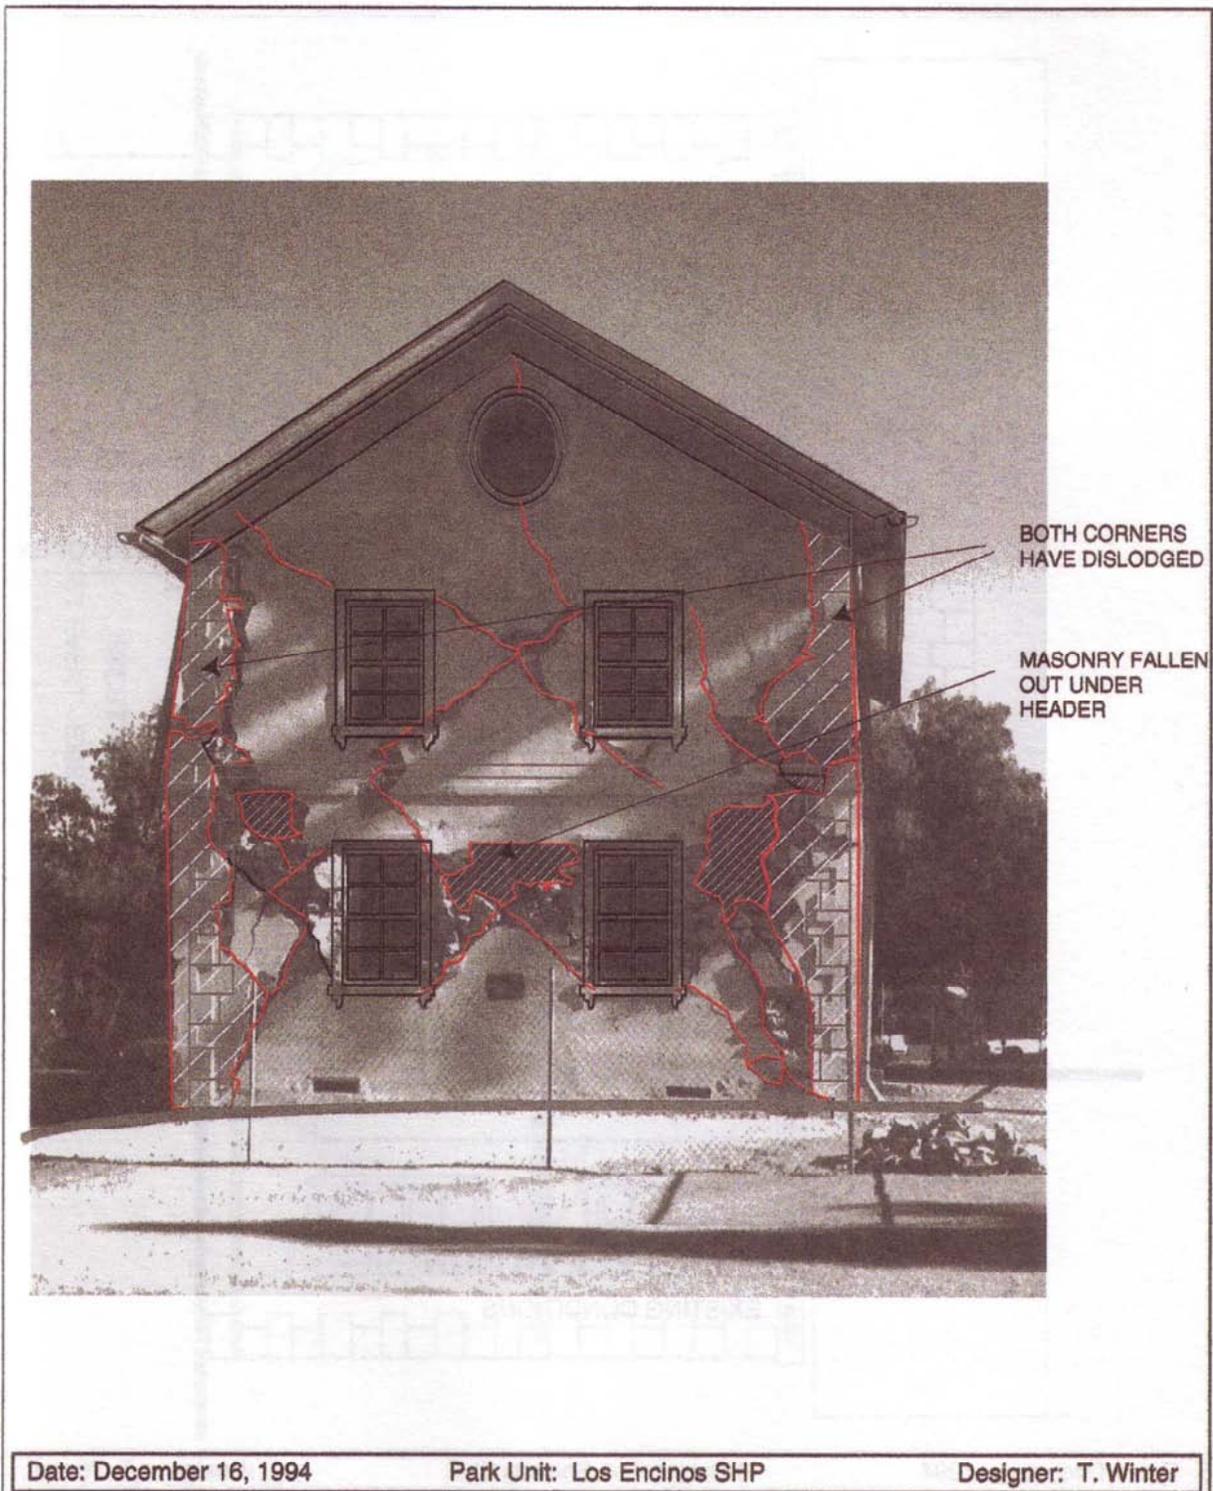
Figure 18.2 Garnier Building: north elevation. Existing condition following Loma Prieta, Dec. 1994. (Photo: Thomas Winter 1994).

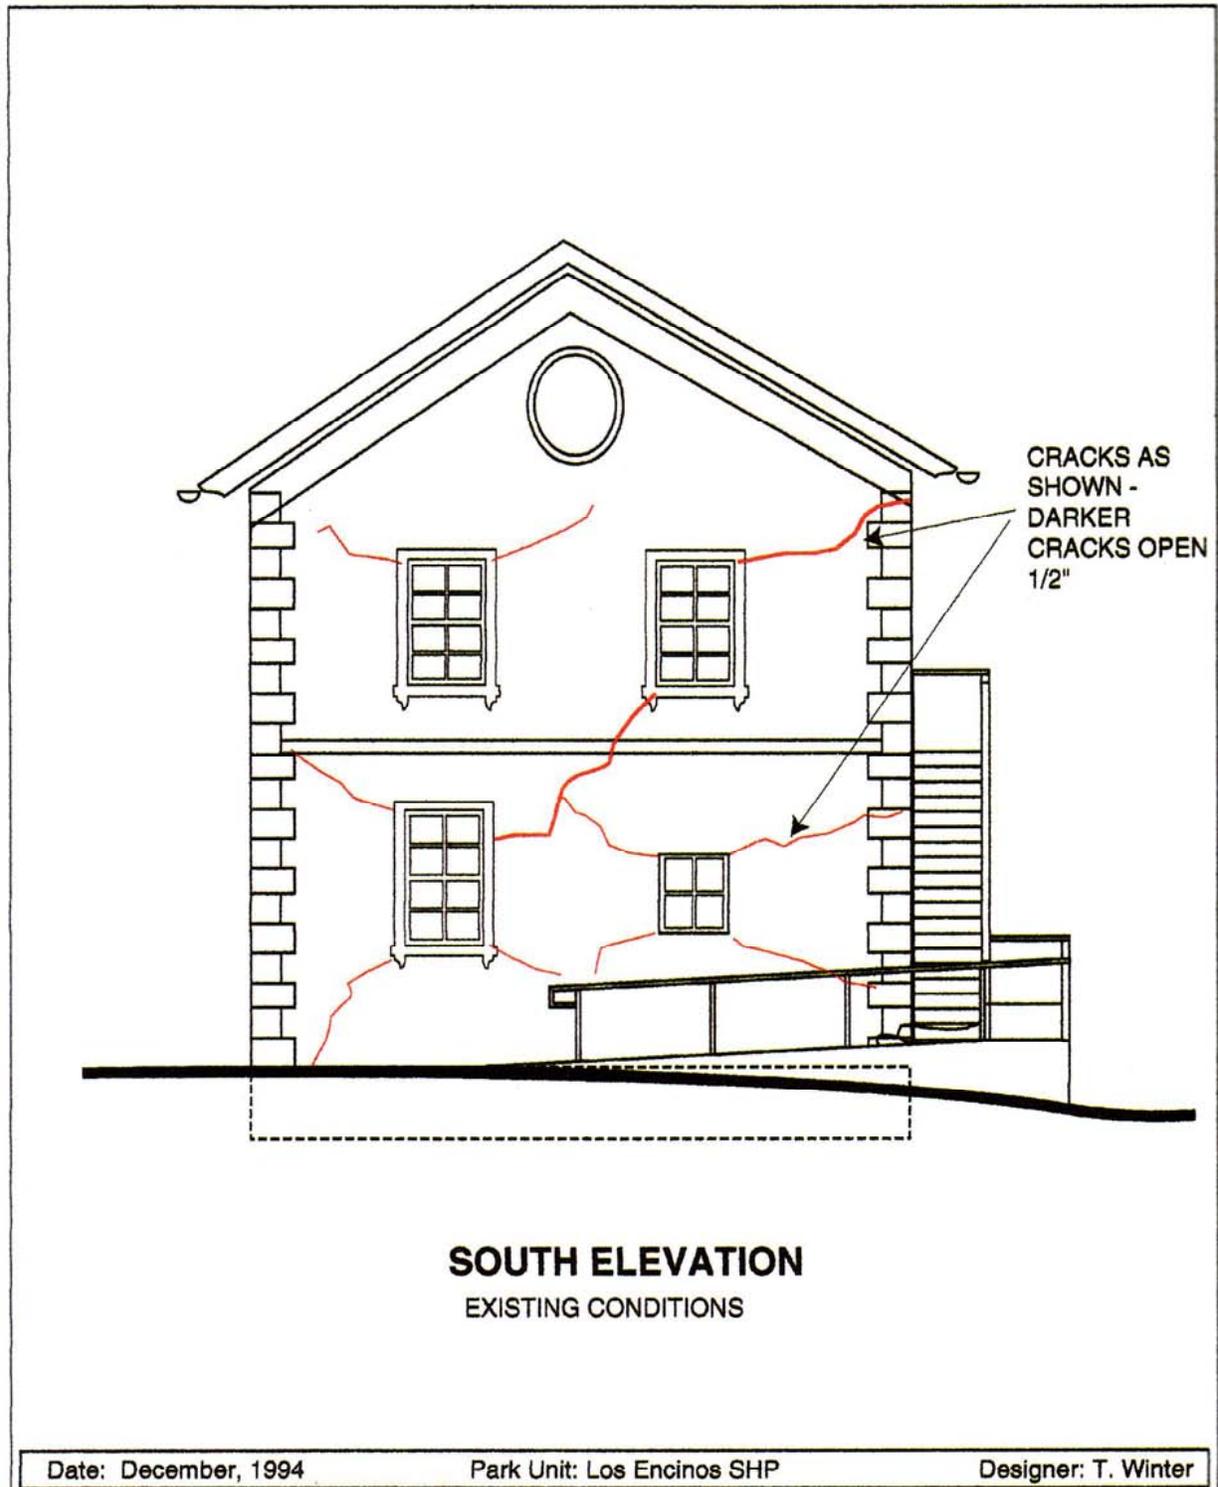
The south wall exhibits fewer diagonal cracks since it is protected by a shear wall located one third of the building length from the south wall. The cracks range from hairline to 0.5 inch (1.27 cm).

Figure 18.3 Garnier Building: south elevation. Existing condition following Loma Prieta, Dec. 1994. (Photo: Thomas Winter 1994).

The general treatment should be sufficient to both repair and upgrade these walls to better lateral resistance. That will include pressure grouting the wall and the cracks.

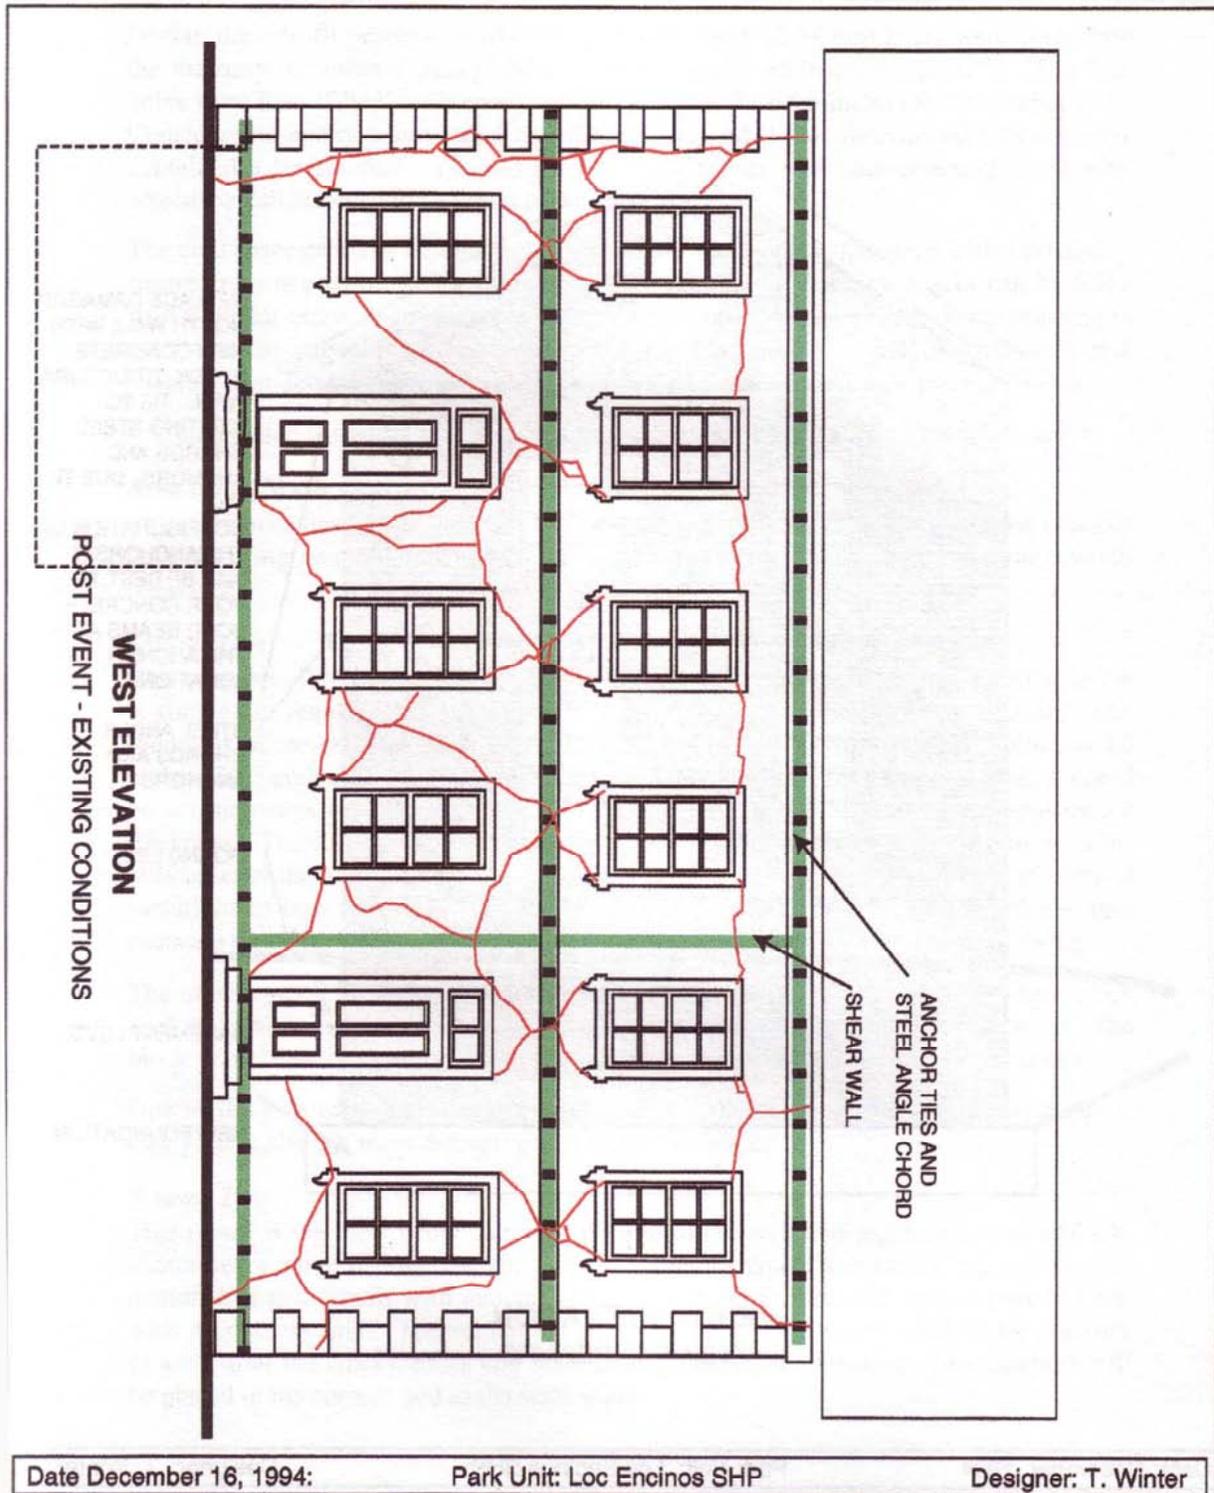
The west elevation exhibits 'X' cracks at each 'pier' below the windows. There appears to be little, if any, amount of out-of-plane offset in the cracks, since this area is tied to the floor by anchors. The lower floor 'piers' area also cracked.

Figure 18.4 Garnier Building: west elevation. Existing condition following Loma Prieta, Dec. 1994. (Photo: Thomas Winter 1994).

Only one scheme is proposed for this wall. The general treatment will be to pressure grout the wall and cracks. Some additional strength is required at the points which cracked severely. Structural plaster is proposed for the inside finish where shown on the drawing. This will be tied to the steel chords and into the rock with epoxy anchors at regular intervals.

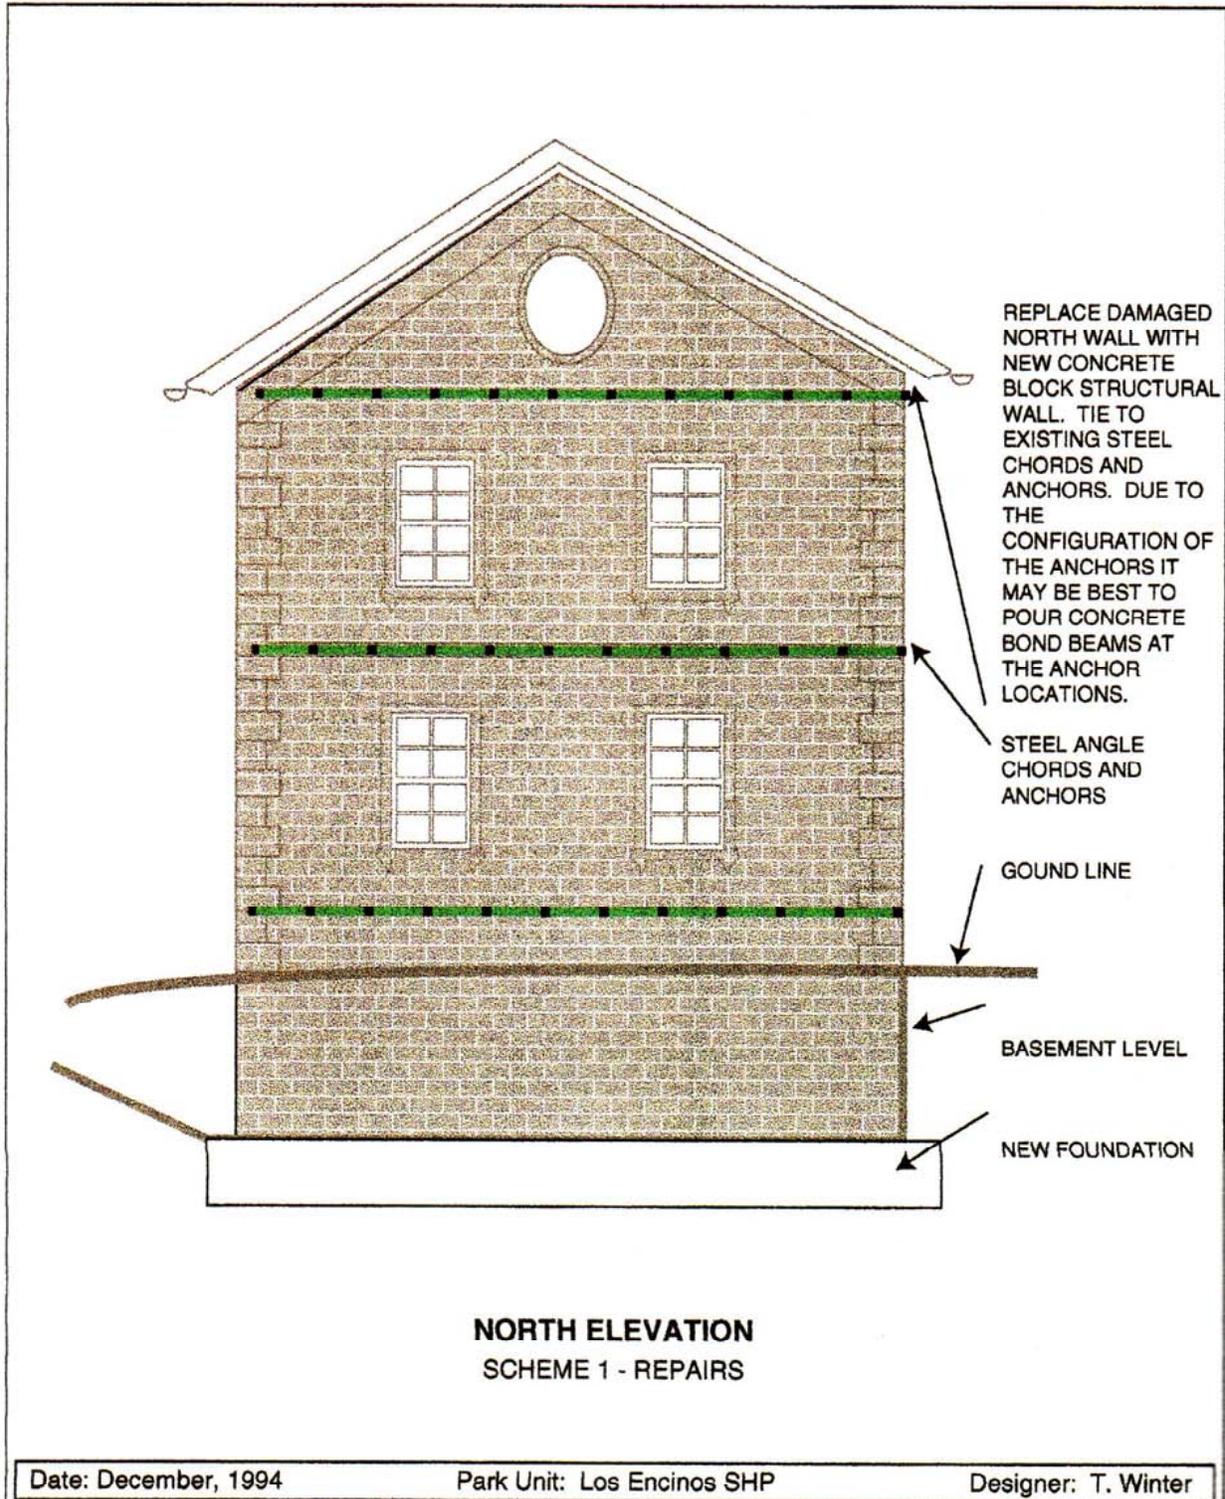
Figure 18.5 Garnier Building: north elevation. Mitigation Scheme One. (Drawing: Thomas Winter 1994).

This removes all of the wall and replaces it with a new concrete block wall. This solution is simple but requires demolition of all of the original historic fabric of the wall. The thickness of the original masonry is about 18 inches (45.7 cm), the widest block is 12 inches (30.5 cm); either the wall must be furred to the proper thickness or the block could be set sideways to make a 16-inch (40.6-cm) wall and plastered to the appropriate thickness. The furring could be constructed of original masonry, but since there is no indication of the masonry underlying the plaster it is not cost effective. There are several variations of how the wall could be configured in the basement level, but scheme one costs are based on removing the existing masonry, excavating and installing a footing.

The masonry will be tied to the structure through the existing steel angle and new grout anchors, which can be cast into the block or into a bond beam poured at that level. The block/bond beam must be set flush with the back of the angle to assure shear transfer.

Due to the cost of demolition, excavation and reconstruction, this scheme is the most costly. It is also the most damaging to the historic fabric.

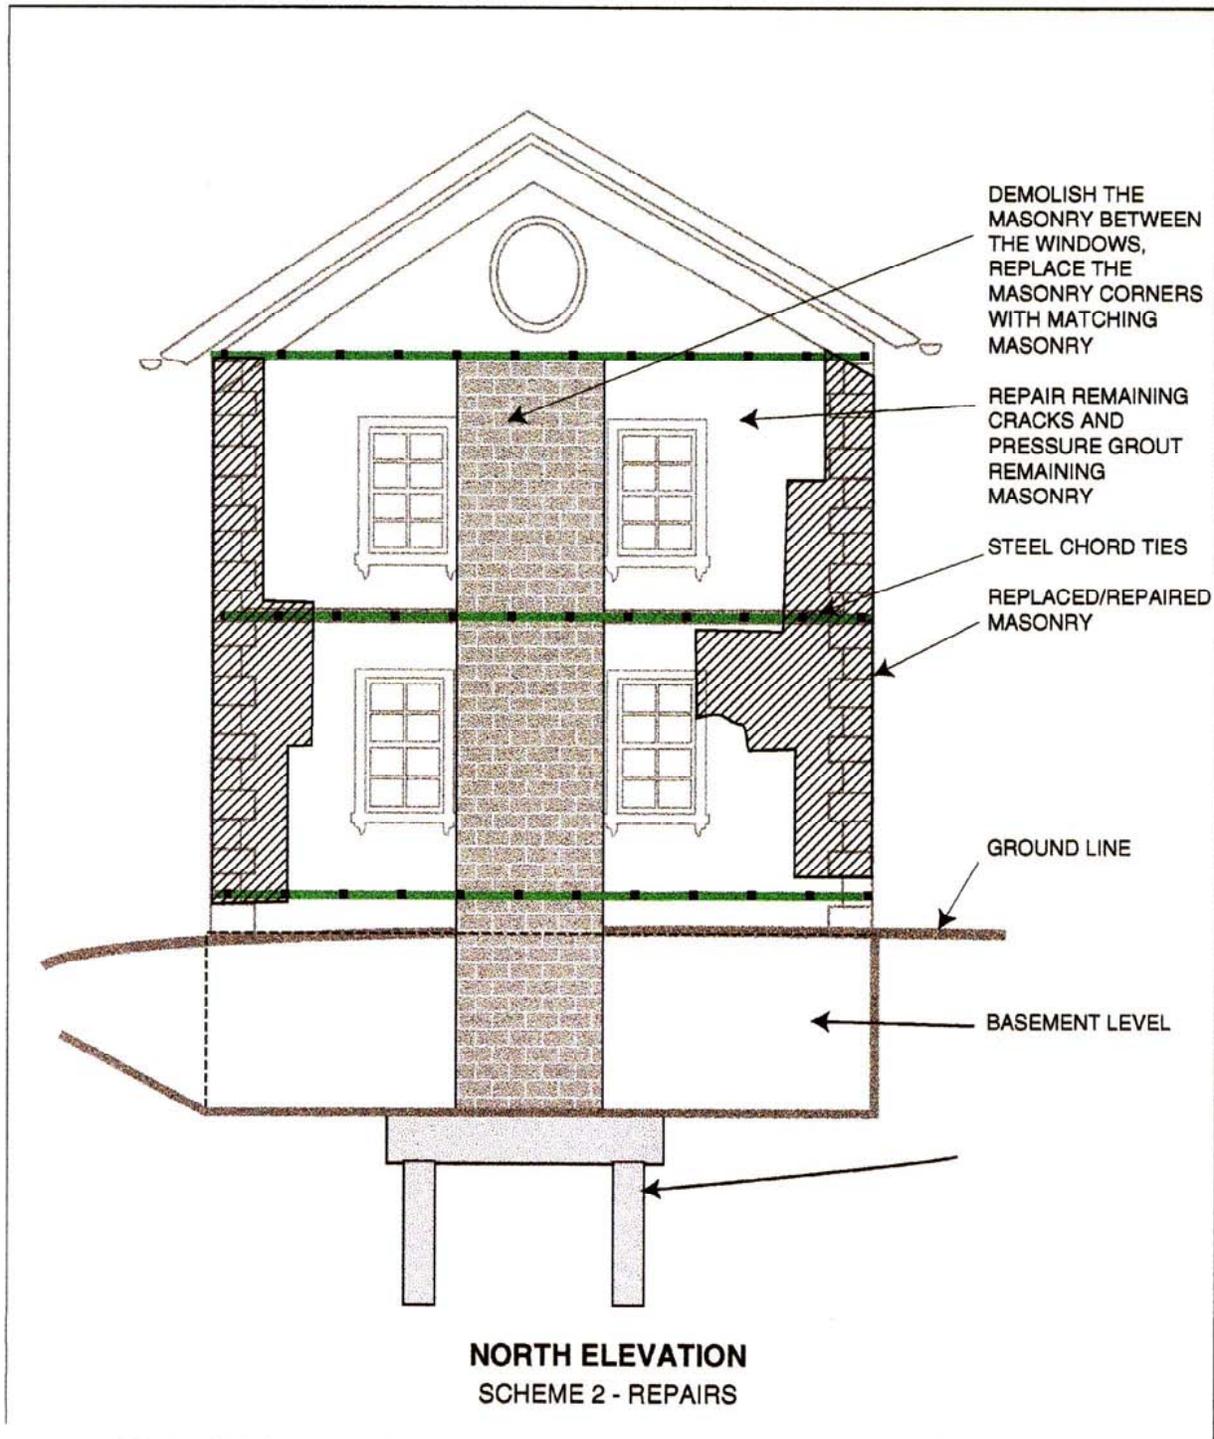
Figure 18.6 Garnier Building: north elevation. Mitigation Scheme Two. (Drawing: Thomas Winter 1994).

This removes the most badly damaged portion of the wall and replaces it with a block, shotcrete or poured concrete shear wall. The damaged and offset corners can be demolished and rebuilt with matching masonry, or be formed and shot or poured back with a concrete mix. The remaining portion of the wall would need to be pressure grouted after the cracks, holes and other damage have been repaired. New anchors will be placed in the corners tied to the steel angles.

The shear wall must be constructed through the basement, and will require a footing and probably piles or piers to develop the lateral resistance required.

This scheme is the least costly and appears to be a viable alternative. Damage to the historic fabric is relatively minor and is perhaps the least. The ties between the angle chord and the new shear wall become very important and must be calculated to assure their adequacy.

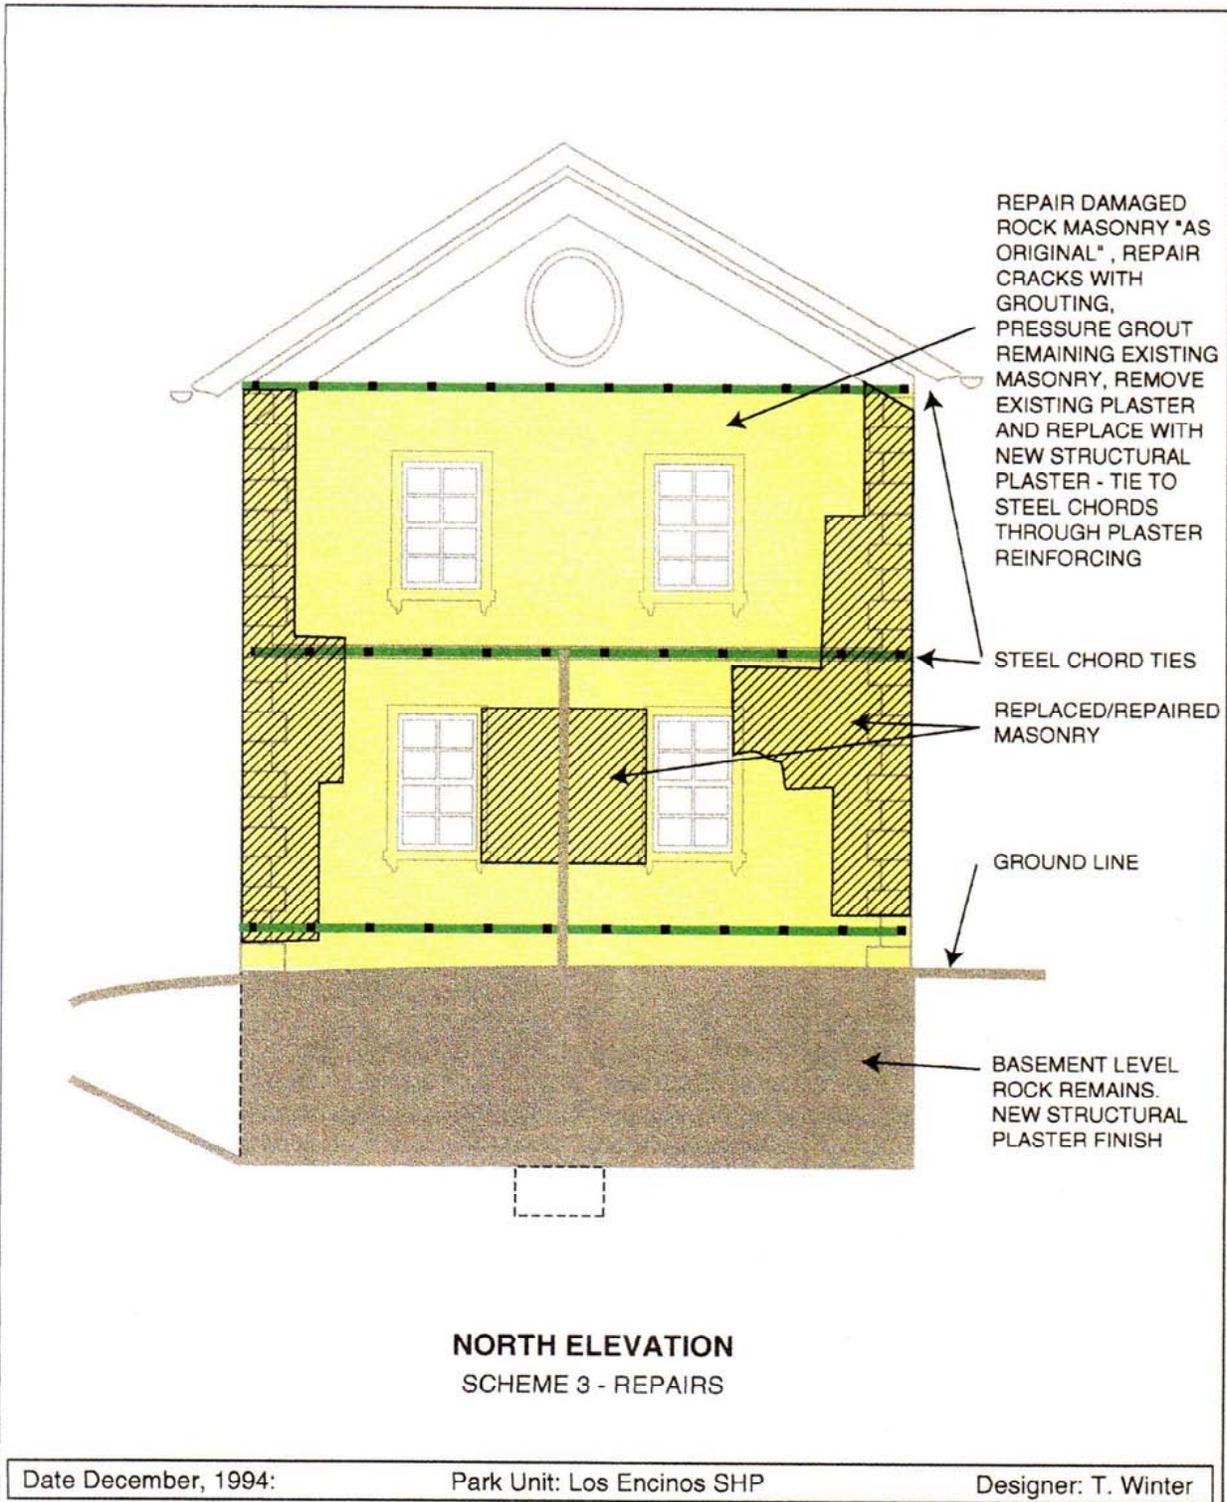
Figure 18.7 Garnier Building: north elevation. Mitigation Scheme Three. (Drawing: Thomas Winter 1994).

This requires the least demolition; only the displace corners would need to be removed and reconstructed. The holes will be built up of matching masonry. The foundation appears to have suffered little damage and can be reused.

To carry the seismic loads better, this wall will be upgraded. The plaster finishes will be removed from the top steel angle chord to the base of the wall and replaced with a reinforced 'structural plaster' which will be tied into the steel angle chords at each level. This scheme assumes that both inside and exterior faces will be treated and tied to each other by steel rods drilled at regular intervals. The plaster will be carried around the corners to tie into the anchors along the long walls. In addition, new corner anchors may be required to secure the corners which failed in this last event.

This scheme retains the most historic masonry but requires that significant amounts of plaster be removed to develop the required strength. The cost is very close to Scheme Two and is therefore a viable alternative.

Since this alternative requires no excavation, a problem in archaeological sensitive sites, it is the preferred alternative. The cost of archaeological monitoring and testing would make Scheme Two more costly.
