JOURNAL OF THE HUMANITIES AND SOCIAL SCIENCES

SUBMERGED CULTURAL AND HISTORIC RESOURCES OF MALOELAP ATOLL, MARSHALL ISLANDS

Matthew B. Holly
Marshall Islands Aquatics

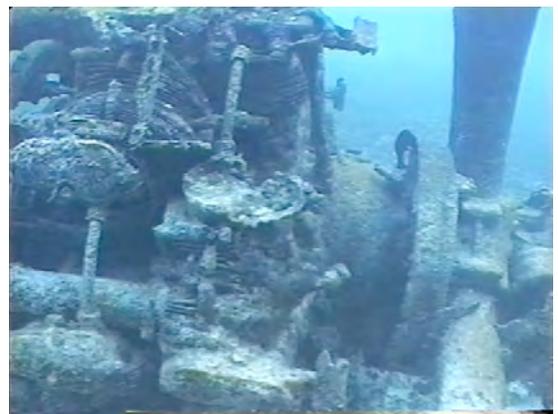
The aircraft engine is the prominent artifact at the site (Figure 3). It sits on a sandy bottom with coral growth over remaining portions of the aircraft (Figure 4). No fuselage or empennage sections remain other than what is deeply buried in the sand or coral. A portion of the wing, notably the right wing, lies on the sandy bottom nearby (Figure 5). Small shards of aircraft aluminum or aeronautical debris are found throughout the immediate area, covering an approximate 150 square yard area centered from the aircraft engine point.

Figure 3. Close photo of right side of Sakae engine. No cowling survived, but the blades are still in place.

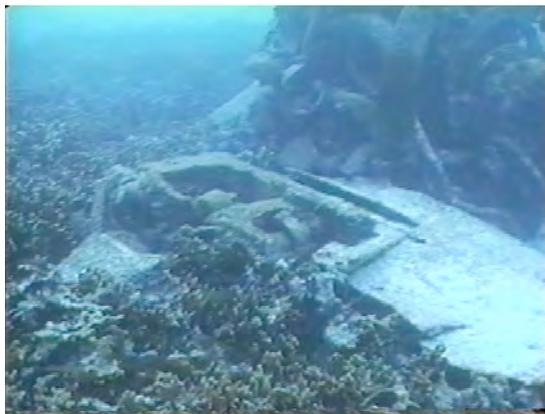
Figure 7. Landing gear is retracted into wing, which may verify a forced landing.

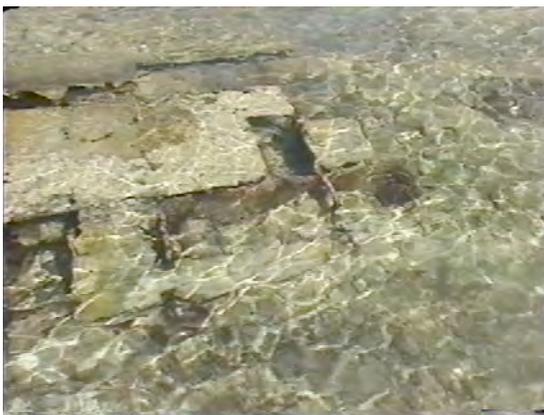
Figure 5. Section of wing from this aircraft was washed towards shore and rests upon a rubble bottom. The main site is approximately 60 yards away.

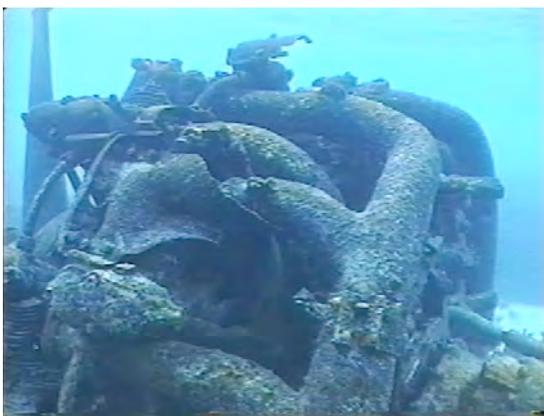
Figure 6. A unique item at the site, the exhaust collectors, is a rare find, as most have been lost over time.

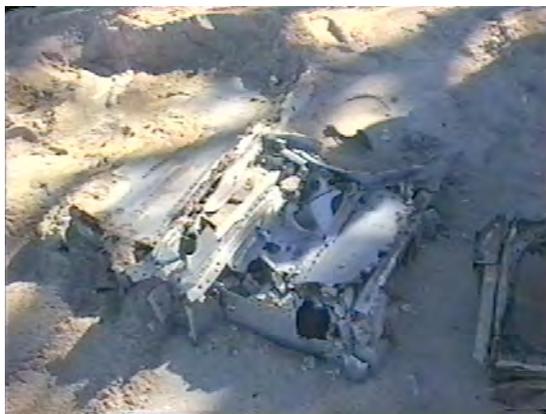
Figure 12. A section of the left wing of the Central Ollet A6M lies partially buried in the sand at low tide. It has torn off at the landing gear area.

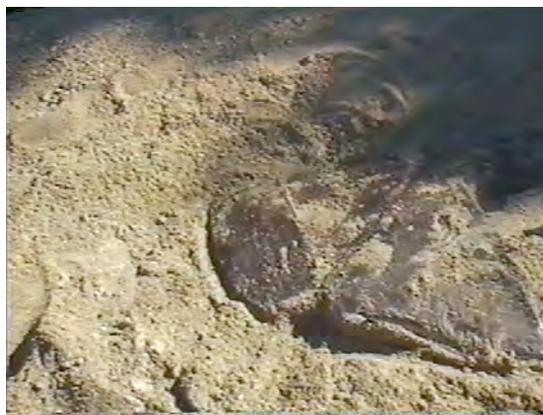
Figure 15. The classic earlier model wingtip was exposed at the end of the wing. This allowed the identification of the wing as that of the left wing.

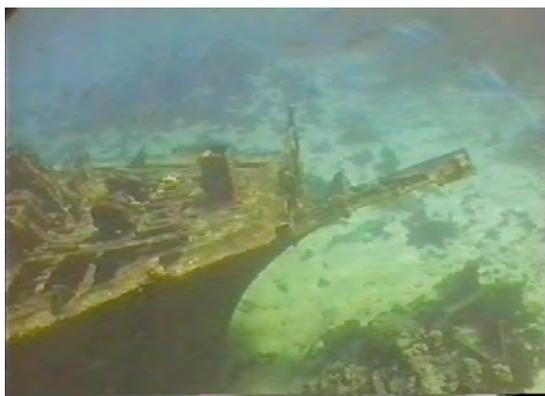
Figure 17. The bow of the vessel Seisbo Maru. Note part of the bow spirit has fallen away. The chain comes out of the port side chain locker and out the port side tube to the anchor. There was no starboard side anchor or chain.

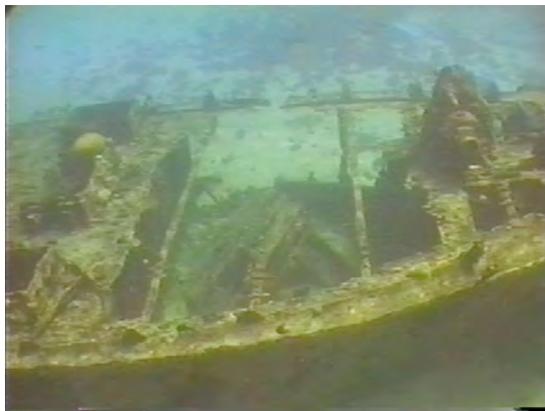
Figure 19. The port side of the vessel at the gun mount position is blown out of the vessel. The mount, and possibly the gun, are in the sand to the left of the hull damage out of view.

The bow gun was probably a 20 or 40mm unit, and if not damaged to severely, was probably recovered. So part of the gun remained in the sand, but I did not have time to dig and inspect it. I found no ammunition of any kind at the site, as usually the stern would have a light machine gun and ammunition nearby.

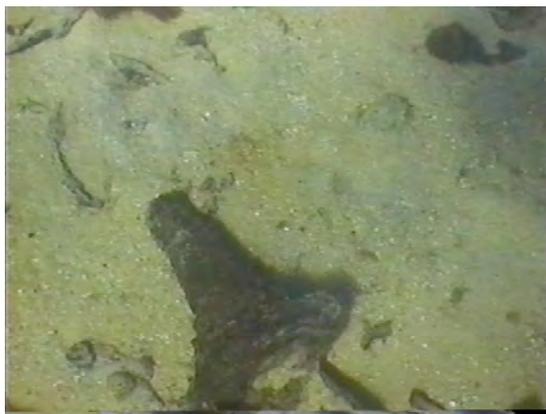
Figure 20. The gun pedestal lying in the sand. The welded mount is nearby.

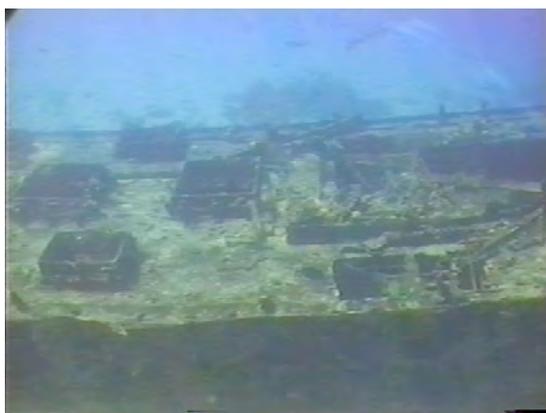
Figure 22. The Seisbo Maru mid-ship. The main deck to the left, the engine room exposed where a pilothouse used to stand. Taken from the port side.

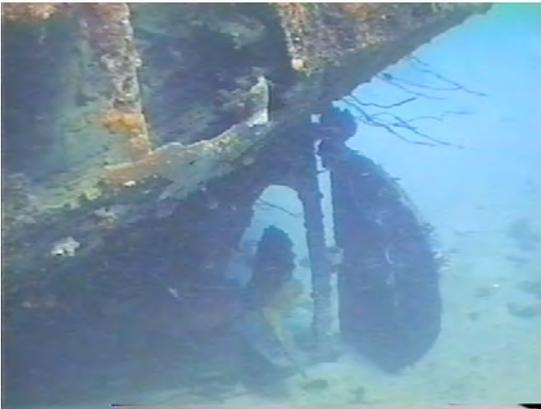
The stern, old style rudder, and the original complete three-blade propeller were intact, less a few steel panels missing on the port side (Figure 27). The vessel had no name on the stern we could determine, and we tried to ask for information from the locals.

Figure 27. Stern of the Seisbo Maru, showing the large (old style unbalanced) rudder, 3-blade propeller complete, and parts of the hull plate missing in the foreground due to corrosion.

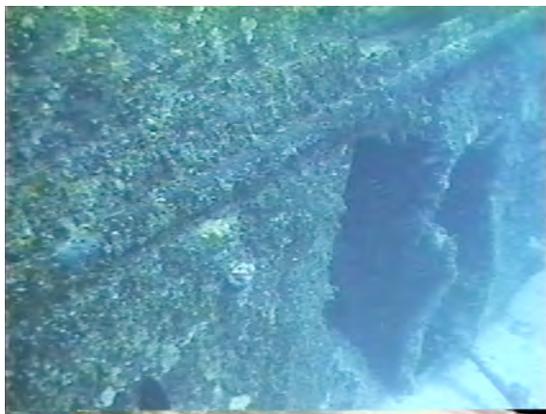
Figure 29. The *Kaikou Maru* was sunk by this damaging near miss bomb blast that holed the engine room area to the sea.

The *Kaikou Maru* was sunk at anchor by a near hit of a medium sized bomb, while tied to the stern of the *Seisho Maru*. A hole was created in the hull on the port side from near deck to keel, adjacent to the engine room ladder (Figure 29). There was no other significant damage to the ship, and only the bow current is holed, probably due to corrosion (Figure 30).

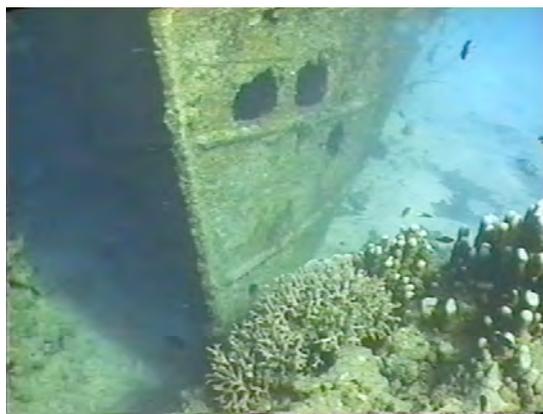
Figure 30. The holes in the bow were probably created by corrosion over time, and not by the effects of war. This was the "wind and water line" area of the vessel, which decays the fastest.

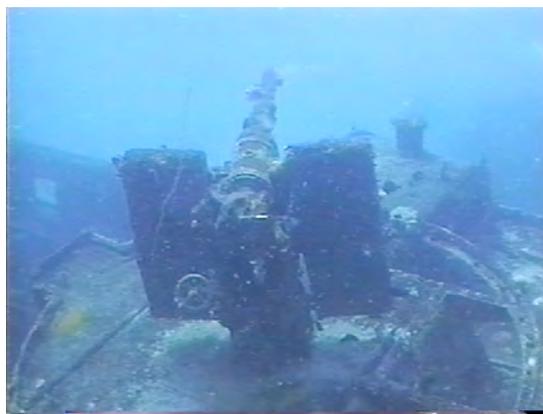
Figure 31. The gun mounted on the bow is the prominent feature of the vessel. It probably fired a 40mm round, but no ammunition was found at the site. A ready ammunition locker generally sat nearby.

the bow (Figure 31). Estimated to be a 40mm unit, the gun has not been molested or stripped of any item, although no ammunition for the gun was found aboard the vessel. The gun was not fired in defense, as it still had its' environmental plug in place (Figure 32). The gun was trained to port (Figure 33), and had all but one of its' sights still in place (Figure 34). It is an unusual find, as I would have presumed the Japanese garrison would have recovered it for their own defense use on shore. They had moved much larger guns from sunken vessels for use as shore batteries in other Marshall Islands bases.

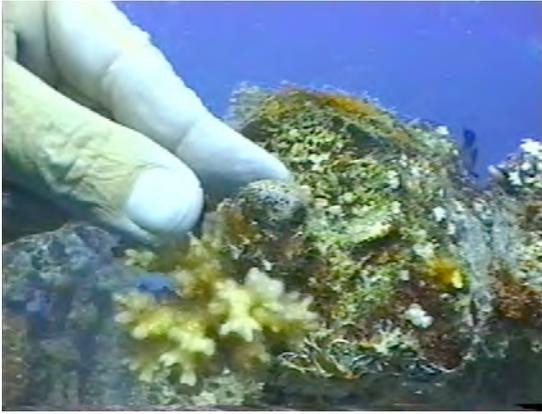
Figure 32. The bow gun was not used for the defense of the ship during the attack, as deduced from the weatherproof plug still being in the barrel.

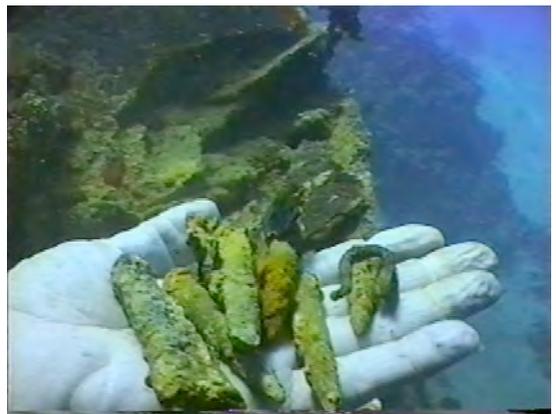
Towards the stern of the vessel on top of the stern deckhouse I found a handful of unused 7.62mm machine gun rounds (Figure 46), supporting the local claim that SCUBA divers removed the gun years ago. It could have also been easily removed by the Japanese garrison forces.

Figure 46. Japanese 7.62 machine gun rounds on the stern deck house roof verifies the vessel had a light machine gun mounted here at one time. It was allegedly removed by SCUBA divers many years ago.

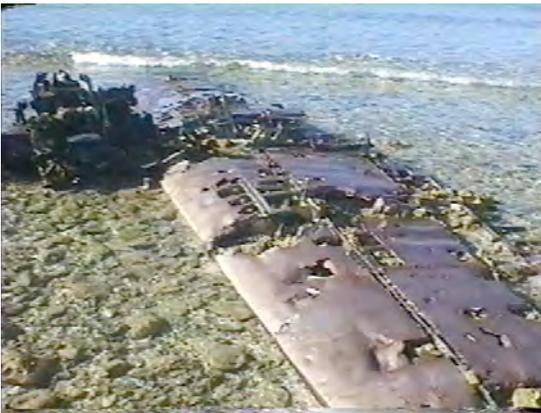
Figure 53. Photograph taken in 2000 shows the same aircraft with notably more holes in the wing, sections of the fuselage and the 20mm cannon missing.

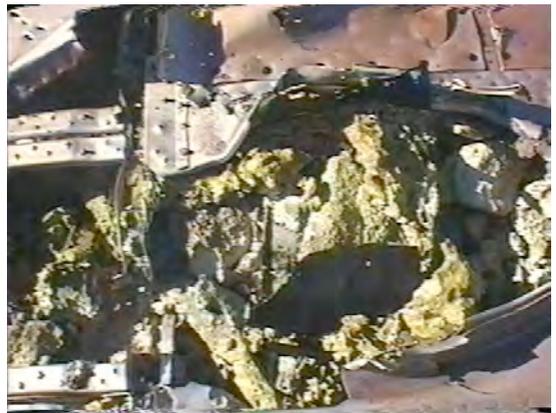
Figure 56. Coral rubble packs every orifice of the aircraft.

formed on many steel parts due to the cathode processes created by the dissimilar metal reactions to the magnesium wing spar and attached magnesium parts. The rest of the metal aircraft skin is heavily damaged, full of coral rocks and rubble (Figure 56), with the remaining aircraft skin worn to a shiny pink hue.

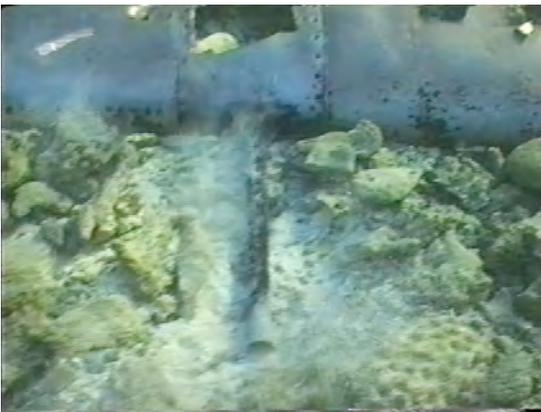
Figure 60. The long barreled 20mm Cannon in the right wing. Note the calcium growth on the barrel tip, protecting the steel from corrosion.

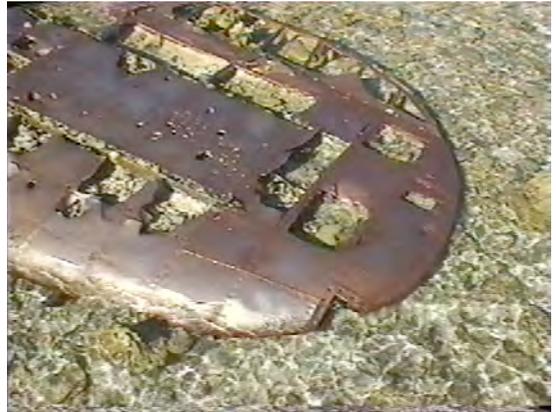
Figure 61. Photo of the left wingtip. This is not a folding wingtip; so earlier identification made it an A6M2 Model 11, which was a lighter production model for Imperial Japanese Navy (IJN) shore based units. As many variants were produced, and field modifications made, it would take a true aircraft expert to determine the exact model.

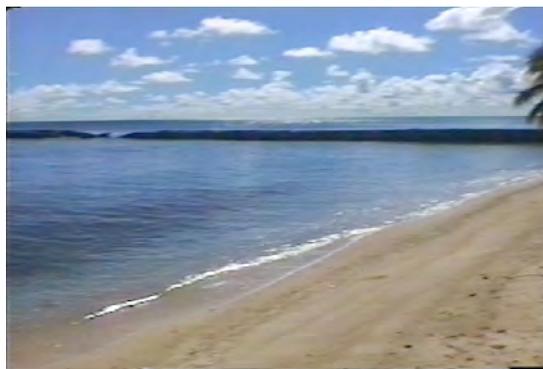
The unique features were the covered internal troughs set in concrete that allowed for installation of water and fuel pipes. They supported both the fuel farm for the power station on the island, and in turn, allowed vessels to be given water from the water collection system built on the island. Much of this water and fuel system is still intact, although the pipes are destroyed within the damaged sec-

Figure 65. The Japanese pier at Pigete Island from the south. Note the damaged section near the end, struck by American bombs during the war.

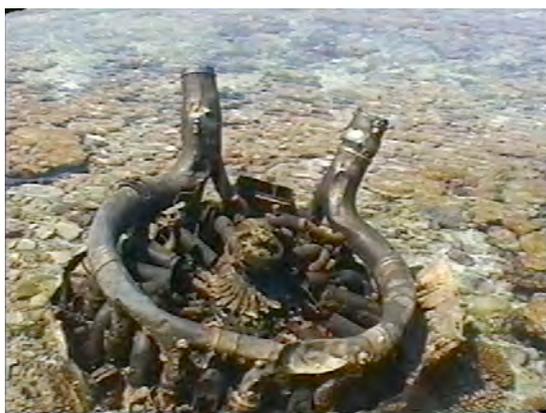
Figure 69. The southern engine of the B-25. All exhaust collector rings are present and attached, with only minor damage.

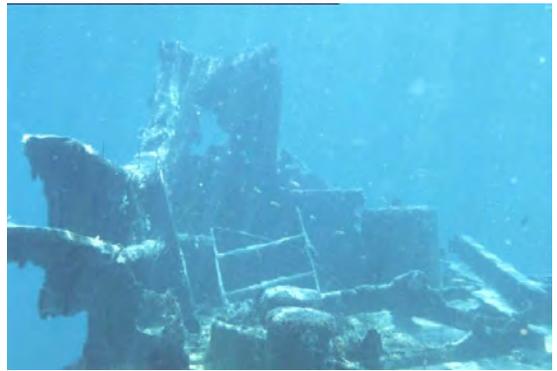
Figure 83. The wreckage forward of the house is scrambled at best. No artifacts of any note were found in the vessel.

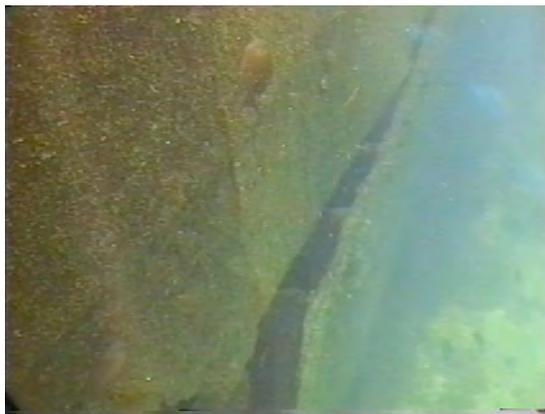
Figure 89. The Demon plate. The loose plate moves and creaks with tidal currents and attracts fish, and sharks. Plate has been loose since author visited the site in 1981.

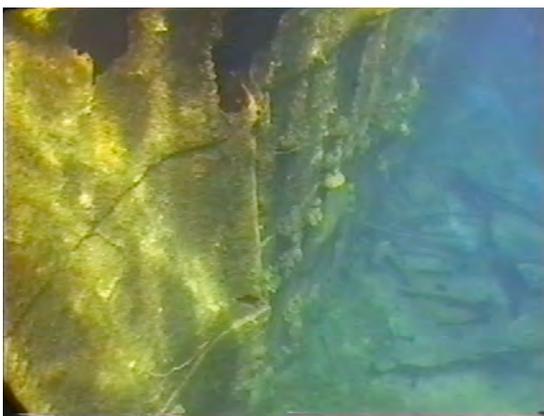
When I was in Maloelap on an earlie trip, I did a video survey of the vessel. In filming down the hull I found a section of port side hull plate bent from top rail to nearly the bottom, that’s about 16 feet of hull plate, straight up and down. The pattern of bending was odd and unique, with the steel crushed into a rippled look, with more and deeper ripples at top of the vessel, and smaller ones towards the bottom. It didn’t register until I found a similar pattern on the exact opposite side of the vessel. It was as if the vessel had been grabbed by the nose and the tail, (bow and stern) and crushed together, with a slight push upwards. This is exactly what happens to a vessel that has a torpedo explode under its’ hull. The explosion makes a temporary air pocket that the vessel “fails” into, breaking the back of the ship. This torpedo ran too deep; and the explosion bent the ship, but did not break it. It limped into the nearest port, the Taroa anchorage.

Figure 88. Torpedo damaged port side. Metal plate was deformed more at the top than bottom. A similar pattern was seen on the starboard side.

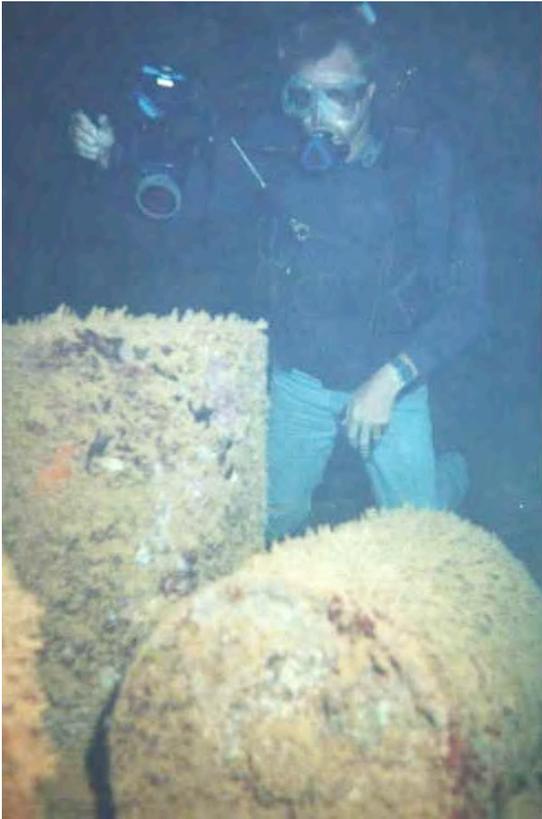
Figure 92. The author poses with six live depth charges. A seventh was seen in the bottom of the hold in 1981, and cannot be seen today. Be careful !!! Japanese depth charges had two pressure diaphragms, one for depth of detonation, one as a safety. The safety cover forks are all gone...

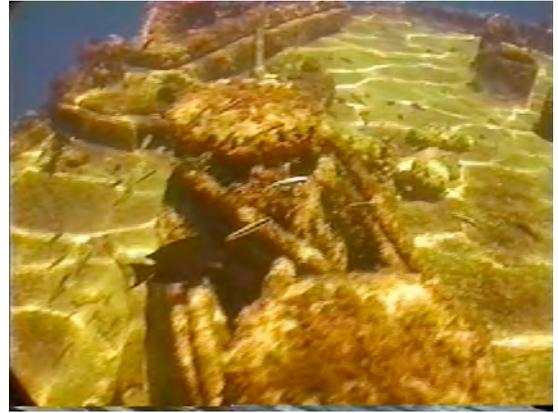
Figure 94. The stern was tied off by hand with heavy cable. This was not a typical way to secure a boat at anchor. This was a way to secure a boat to a certain point, with no immediate plans for departure. It was a mooring, and sealed the fate of the vessel.
