Langenbach, Randolph (1998 [2004]) 'Architectural issues in the seismic rehabilitation of masonry buildings', in *Disaster Management Programs for Historic Sites*, eds Dirk H. R. Spennemann & David W. Look. San Francisco and Albany: Association for Preservation Technology (Western Chapter) and The Johnstone Centre, Charles Sturt University. Pp. 75-90.

Architectural issues in the seismic rehabilitation of masonry buildings

RANDOLPH LANGENBACH[¶]

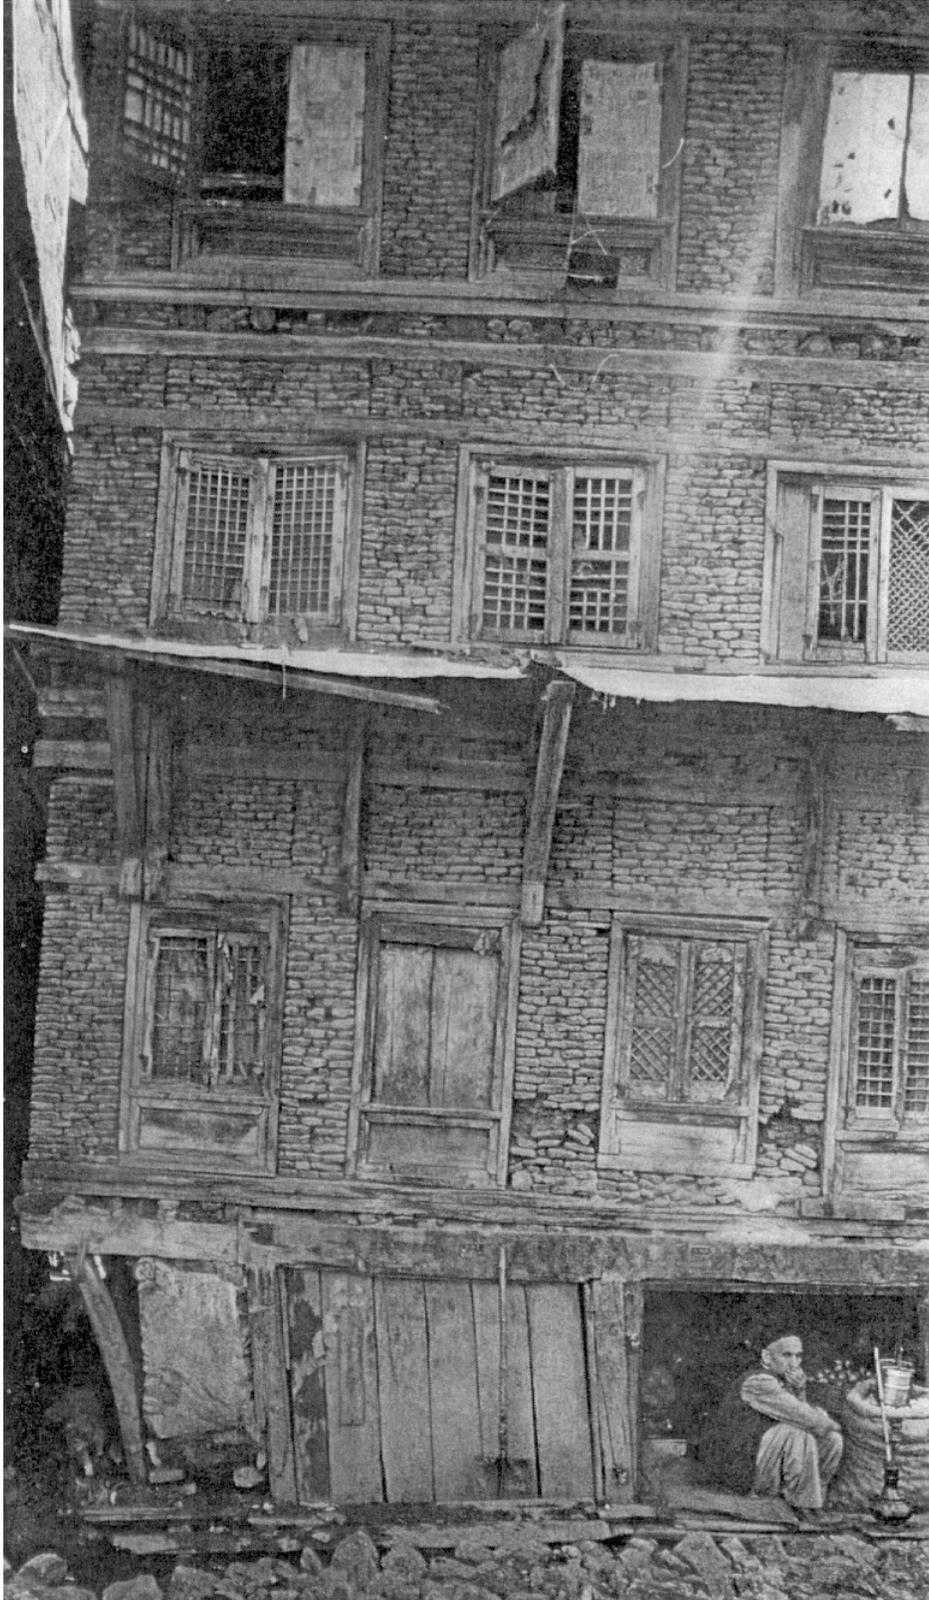
Figure 14.1. This building in Kashmir illustrates the combined timber and masonry construction which was developed to resist the earthquakes which frequently affected this soft soil lakeside site. The timbers only run horizontally, but they serve to tie the masonry construction together.

In places as diverse as Turkey, Yugoslavia, Kashmir and Nicaragua, indigenous forms of construction were developed or adapted to respond to the earthquake threat where available resources demanded that masonry continue to be used. In Kashmir, an elaborate system of

interlocking horizontal timber runner beams was used, without vertical wood columns, to hold the rubble masonry and soft mud mortar buildings together on the silty soil. Historical reports confirm that these buildings withstood earthquakes better than the nearby unreinforced brick palace and British-built government buildings.

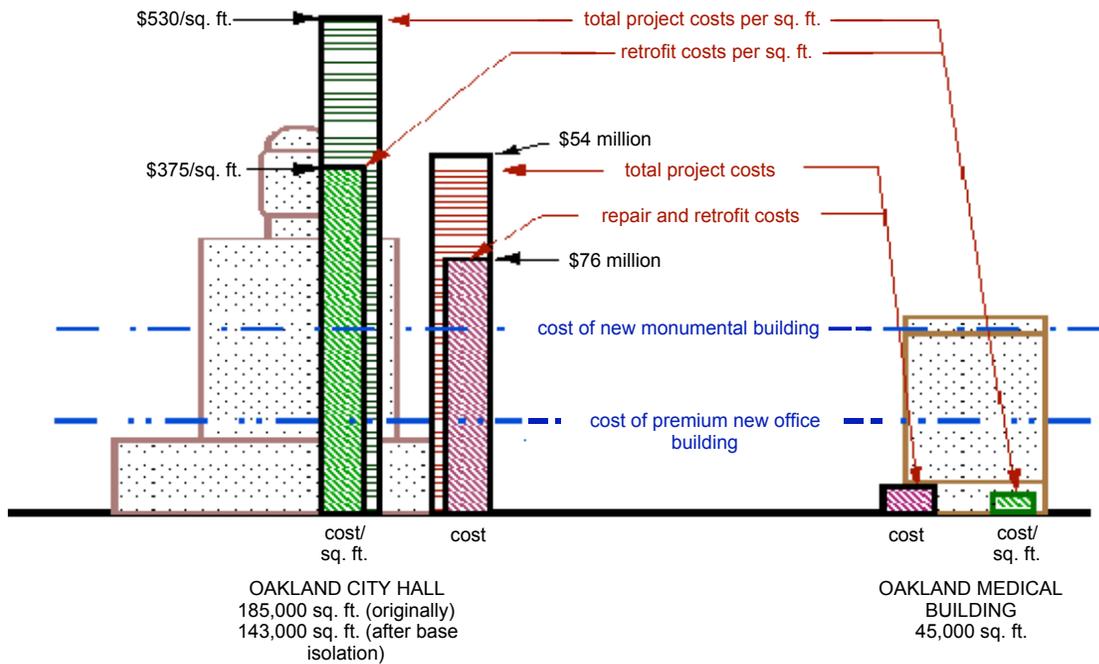
Figure 14.3. Cost comparison between two retrofit projects

The crisis can be illustrated by an example in Oakland, California, where one brick- and terracotta-clad steel frame historical building, the City Hall, is being repaired from Loma Prieta Earthquake damage and seismically upgraded at the extraordinary cost of US\$530 per square foot (US\$5,700/square meter), which is more than three times the cost of a new building of comparable quality. Six blocks away, another office building, the Oakland Medical Building, was just repaired and seismically upgraded to the same codes for a cost of only US\$11 per square foot (US\$118/square meter). The City Hall design uses the now popular newly developed base isolation technology, while the Medical Building is a fixed base design, but both schemes were promoted as 'cost effective' designs to meet the requirements of the building code (see Figure 14.3).

With a difference between two projects, both promoted as necessary and expedient, of over 35 times, it is evident that there is little consensus in this particular field over what is required and beneficial to meet the seismic threat. While certainly the expected performance of the base isolated design is greater than the fixed base design, and even though part of the difference is for interior remodeling of the City Hall, it is questionable whether this justifies 35 times the cost. While many celebrated the repair and upgrade solution for City Hall because it preserved the building, historic preservation suffers in the long run from such
