Osborne, E. (1998 [2004]) 'Disaster Response for the Oklahoma City Bombing', in *Disaster Management Programs for Historic Sites*, eds Dirk H. R. Spennemann & David W. Look. San Francisco and Albany: Association for Preservation Technology (Western Chapter) and The Johnstone Centre, Charles Sturt University. Pp. 145-148.

Disaster response for the Oklahoma City bombing

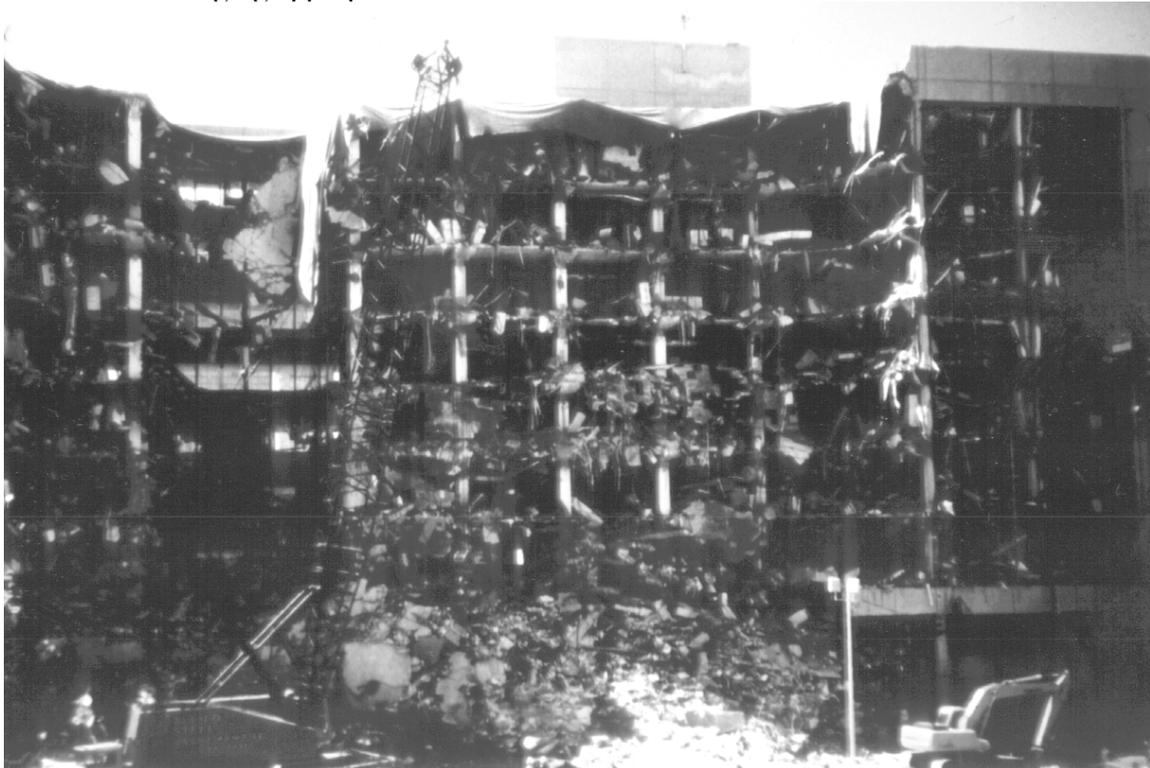
Figure #.1 The Alfred P. Murrah Federal Building after the bombing on 19 April 1995

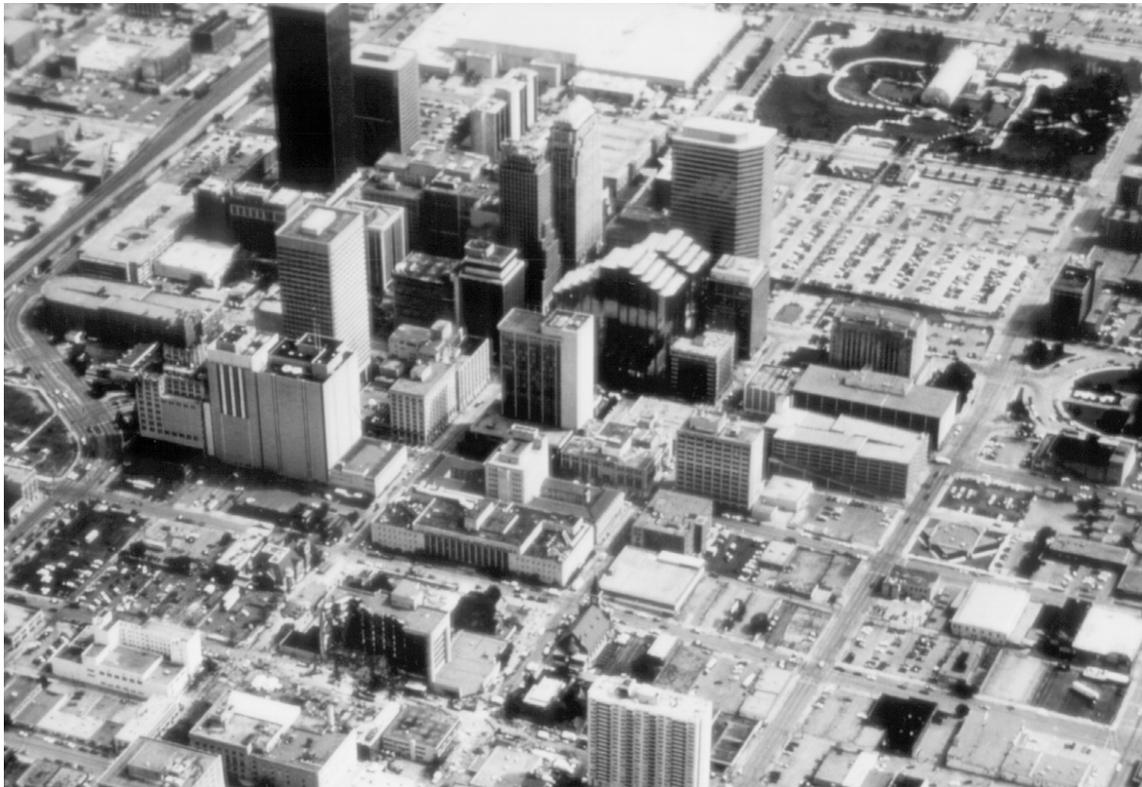
Figure #.2. The city center of Oklahoma City after the bombing. The Alfred P. Murrah Federal Building is located in the left foreground.
