WEED INFESTATION AND ITS IMPACT ON THE PRESERVATION OF A JAPANESE-ERA CONCRETE BUILDING IN MICRONESIA The Agricultural Research Station, Pwunso, Nett, Pohnpei

Dirk HR Spennemann

David Lorence

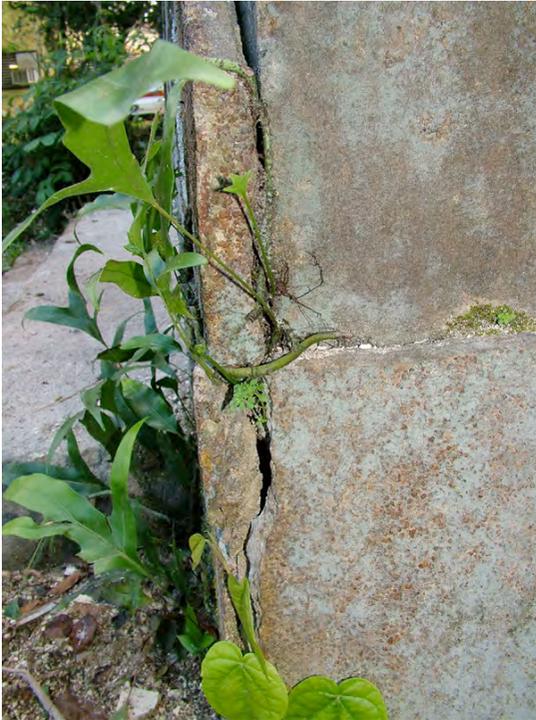
Figure 1. Colonization of a small crack by *Microsorium scolopendria*.

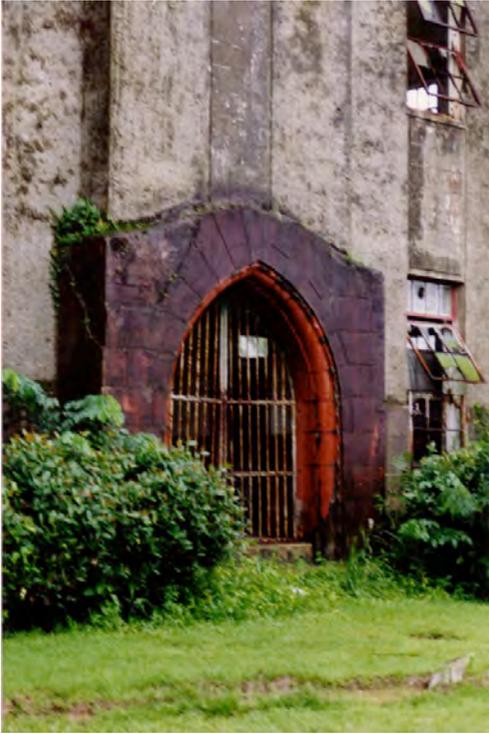
Figure 8. Weed infestation at main entrance on the southern façade of the Japanese Agriculture Building November 1992

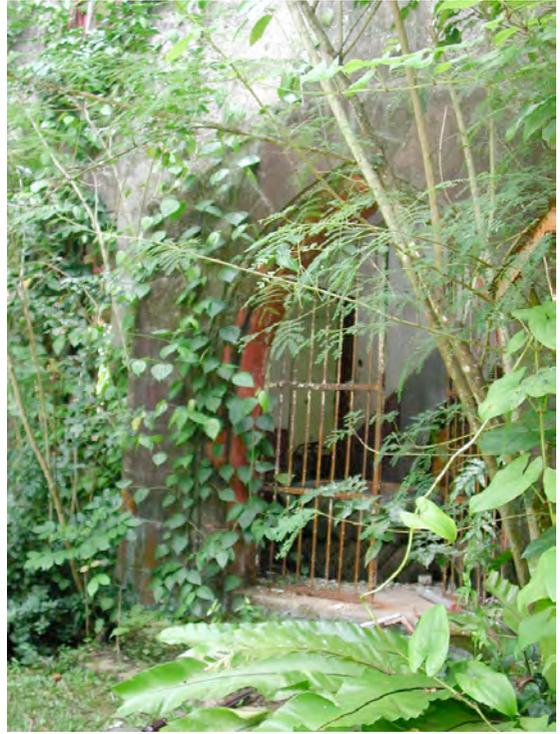
Figure 9. Weed infestation at main entrance on the southern façade of the Japanese Agriculture Building January 2005

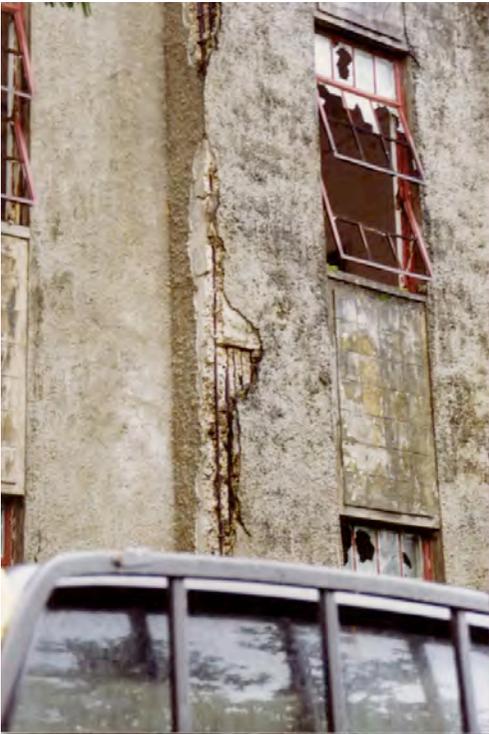
Figure 10. Weed infestation on the southern façade of the Japanese Agriculture Building November 1992

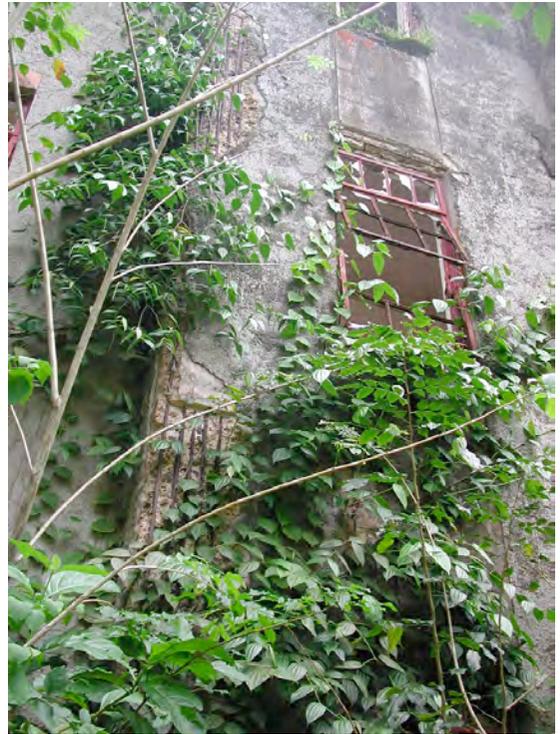
Figure 11. Weed infestation on the southern façade of the Japanese Agriculture Building January 2005

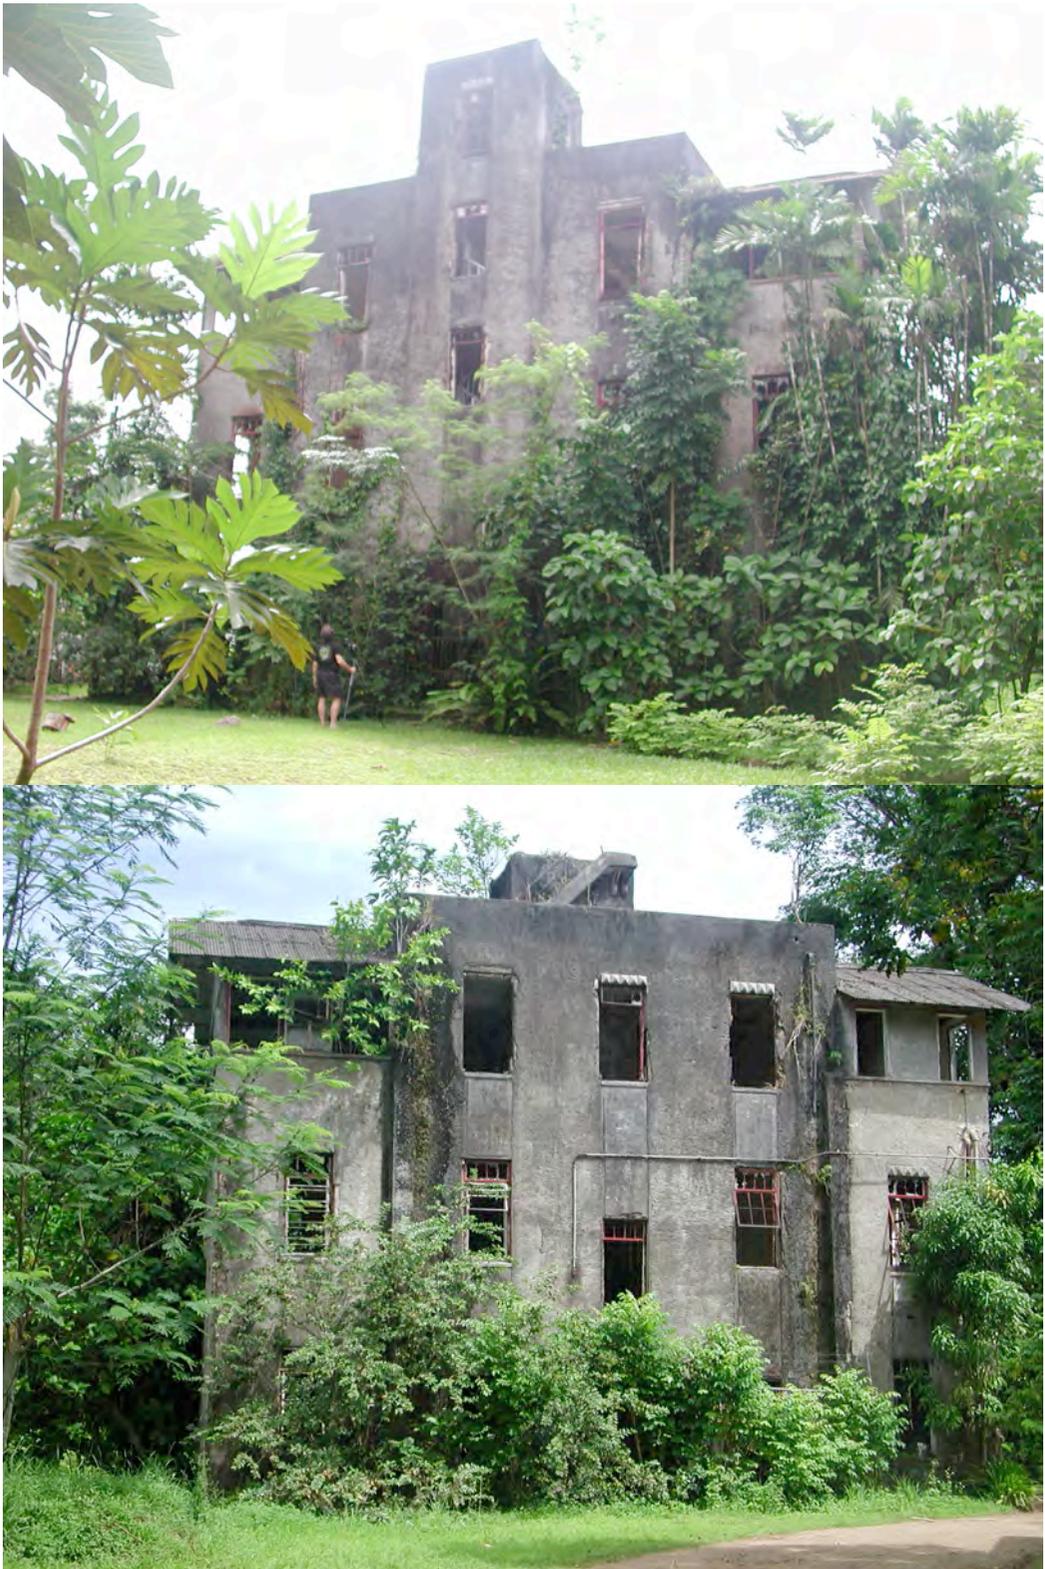
When engulfed in vegetation with just the upper sections of the building protruding, even the Japanese Agricultural Research Station building under discussion here possesses aesthetic values as a ruins (see Figure 12 top).

Figure 12. Dense plant growth, even if rooted in soil and not the masonry, sets up a moist microclimate that retains moisture long after rainfall has ended. Top: northern façade; bottom: southern façade as photographed in January 2005.

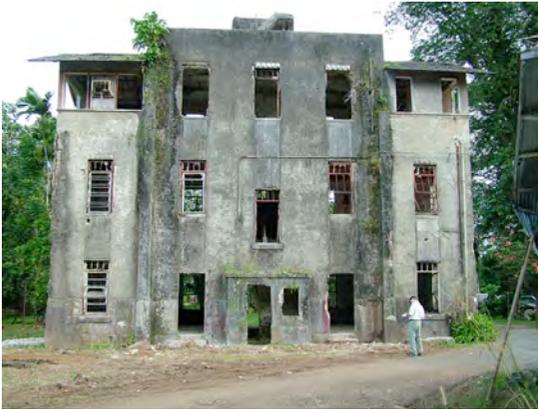
Figure 13. Appearance of the southern façade at the time of documentation in January 2006.

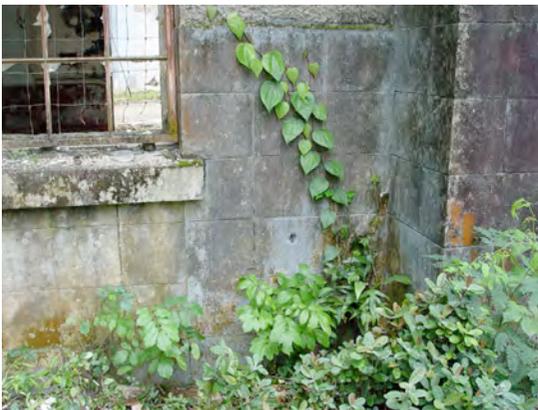
Figure 14. Rapid recolonisation of the wall surface by the ground rooting *Piper ponapensis* var. *trukensis*.

The rate on infestation, as evidenced by the rapid regrowth and recolonisation of the recently cleared surface demonstrates (Figure 14, Figure 17) it is imperative that ongoing maintenance and management of the currently abandoned structure occurs if it shall not decay further while conservation management options are being developed.

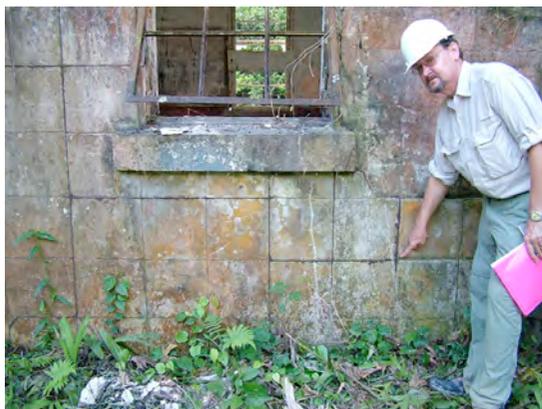
It was these conditions that gave rise to a termite infestation by species termites setting up a above-surface tunnel system on the external wall, including a nest in one of the window corners (). Had the wall been fully exposed to sunlight and thus drying conditions, that infestation is unlikely to have occurred.

Figure 16. Above-surface tunnel system of termites.

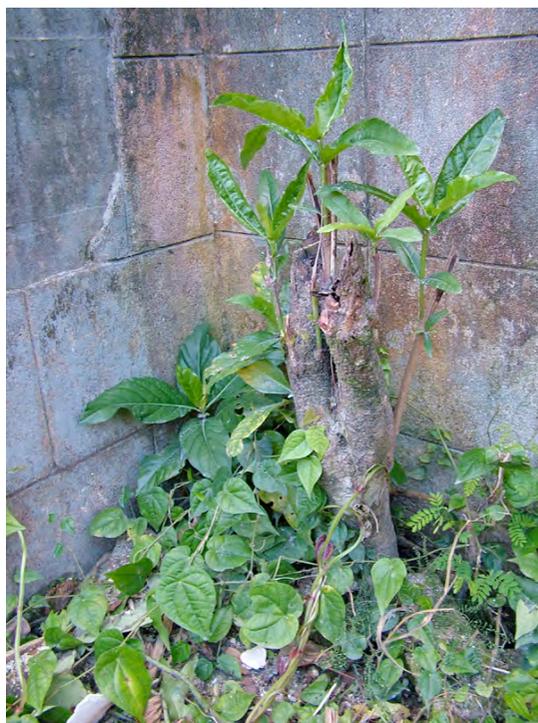
Figure 17. Cutting back vegetation has no lasting effect unless the stumps are poisoned. Two-week old regrowth at the base of the northern façade.

Maintenance of the building should include routine cleaning of accumulated debris and leaf litter and constant eradication of young plants and seedlings as they appear. An initial eradication of the algal growth is indicated. While chlorox bleach applied as a spray would control the algae and mosses very easily, it is necessary to assess the impact of the spray on the stucco (cf. Mouga & Almeida 1997).
