JOURNAL OF THE HUMANITIES AND SOCIAL SCIENCES

SUBMERGED CULTURAL AND HISTORIC RESOURCES OF MALOELAP ATOLL, MARSHALL ISLANDS

Matthew B. Holly
Marshall Islands Aquatics

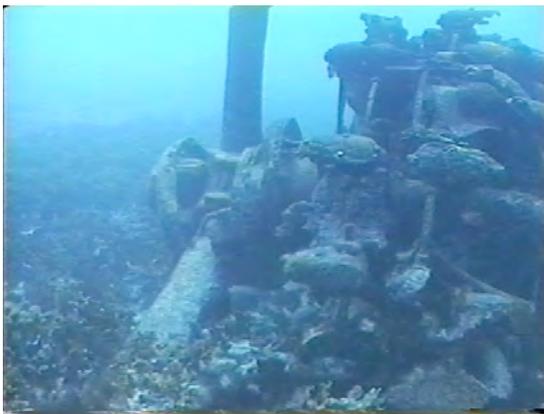
The aircraft engine is the prominent artifact at the site (Figure 3). It sits on a sandy bottom with coral growth over remaining portions of the aircraft (Figure 4). No fuselage or empennage sections remain other than what is deeply buried in the sand or coral. A portion of the wing, notably the right wing, lies on the sandy bottom nearby (Figure 5). Small shards of aircraft aluminum or aeronautical debris are found throughout the immediate area, covering an approximate 150 square yard area centered from the aircraft engine point.

Figure 4. Engine and propeller sit upright amongst the coral and sand.

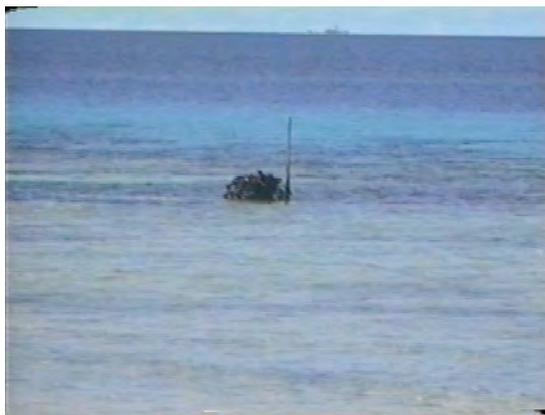
The site is visible from shore at low tide (Figure 8), and offers close inspection (Figure 10). A bullet hole, probable from strafing American planes, shows clearly through the upright propeller (Figure 10).

Figure 8. Photo of the engine exposed at the site during low tide.

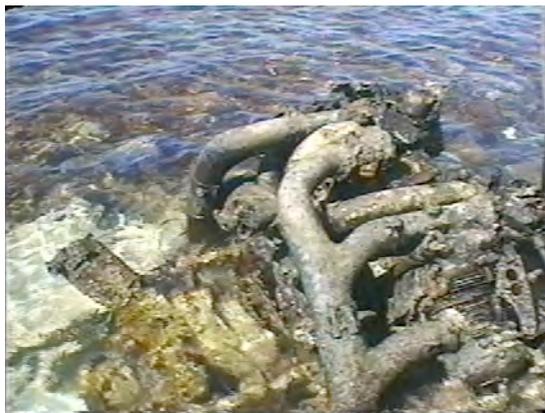
Figure 9. Low tide offers a close inspection of the site.

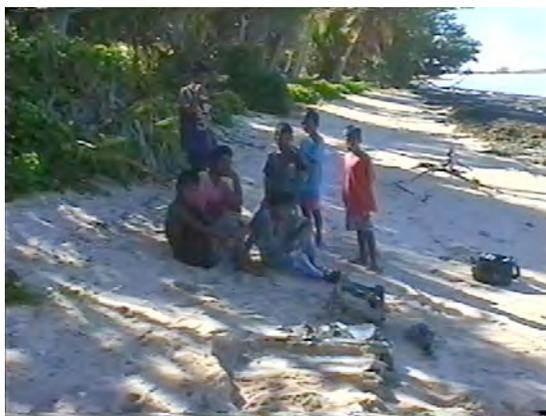
Figure 13. The Ollet Island amateur archaeological sand excavation teams stands during a break in uncovering the artifacts at site 2.

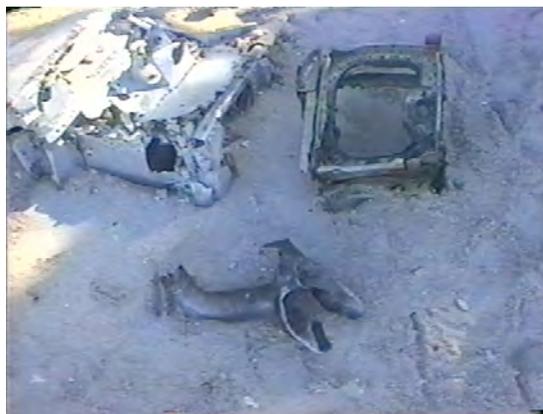
Figure 14. Section of wing from this aircraft was washed towards shore and rests within the sandy beach. An unknown fuselage section is in the upper right, and an exhaust collector segment is in the lower center. The main site is approximately 100 yards away.

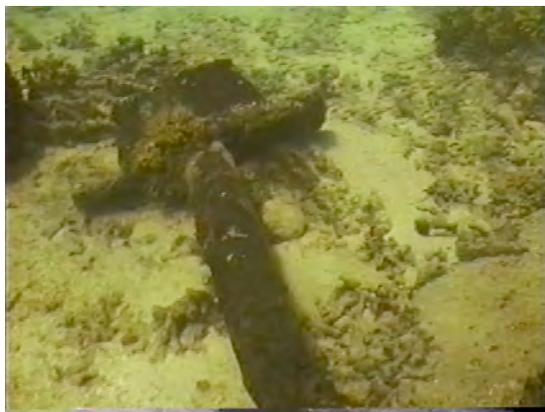
The ship was anchored in shallow water with an approximate 1,000-pound naval anchor, Nelson type (Figure 17, Figure 18). Approximately 150 feet of chain was used, which ran up the port side anchor tube to a windlass on deck. The foredeck survived the bombing,

Figure 18. The anchor of the Seisbo Maru was approximately 1,000 pounds. It was set to the port, and had approximately 120 feet of chain on the bottom.

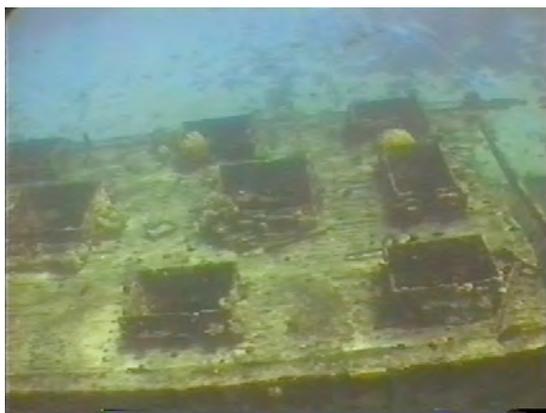
Figure 21. The main deck of the vessel, with fish holds set on steel frames, with a wood deck over the entire vessel. Taken from the starboard side.

The rest of the vessel is interesting to explore, especially below the main deck (Figure

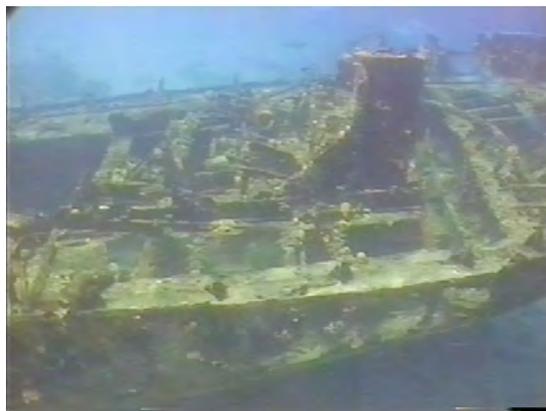
Figure 23. Stern house area of the vessel with the kitchen and the rear of engine room exposed. Taken from Port side.

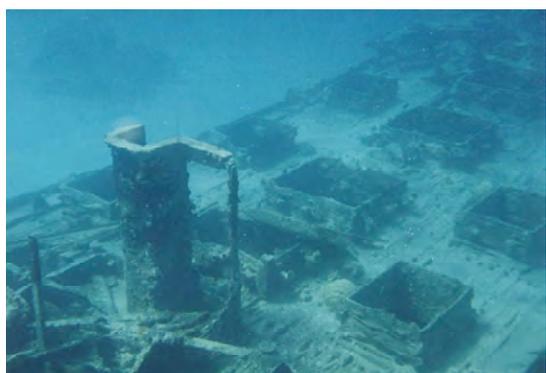
Figure 24. Stern house area of the vessel looking forward. Photographed in 1990.⁸

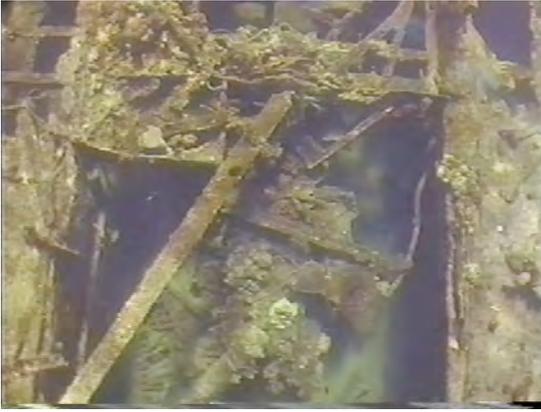
Figure 25. Main engine exposed from missing stern house section.

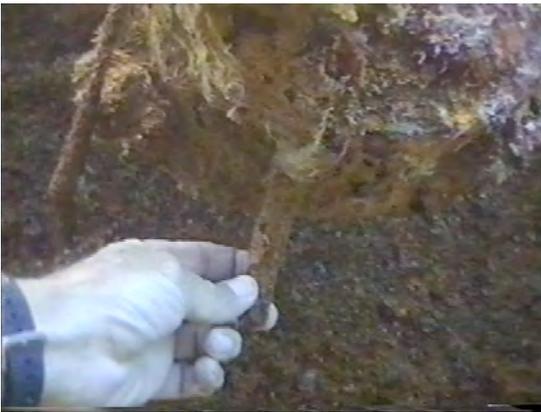
Figure 26. Engine room telegraph to set engine speed survives 60 years.

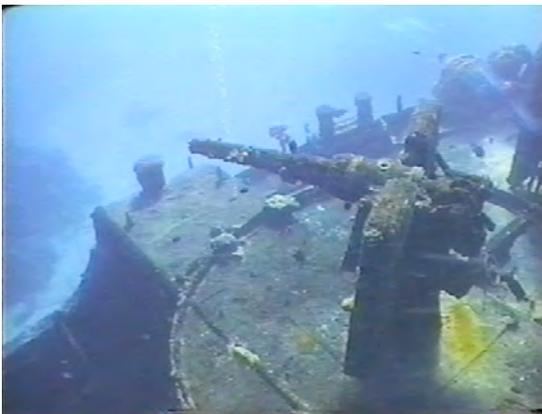
Figure 33. The bow gun trained towards the port side, aft.

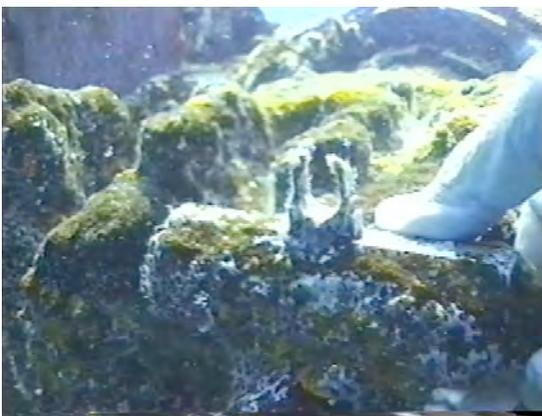
Figure 34. The rear sight of the bow deck gun. The sight was calibrated and made of brass.

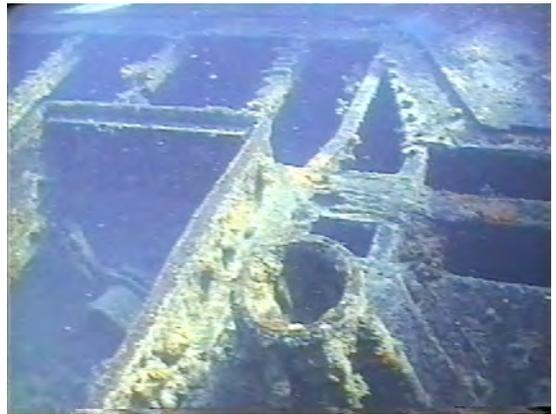
Figure 35. The main deck forward had a wooden mast socket, and the larger hatch behind it was used for easy and clean entry into the hold.

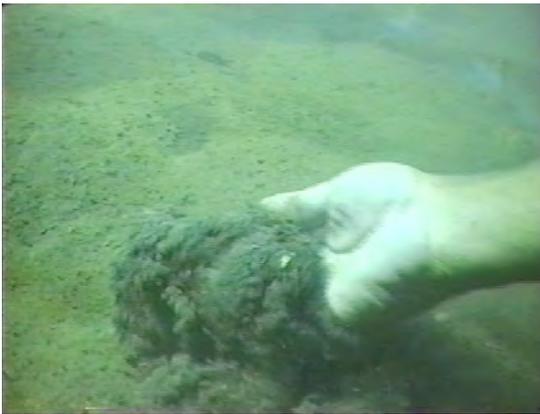
Figure 36. The hold bottom was covered with a thick muck which easily clouded photographic opportunities, but which hid many nautical and period artifacts.

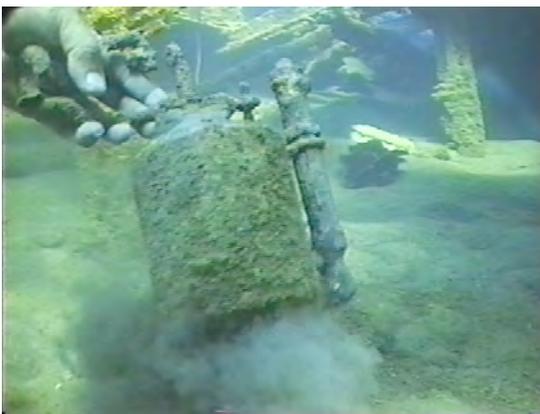
Figure 37. A pump-up blowtorch was found port side forward in the hold.

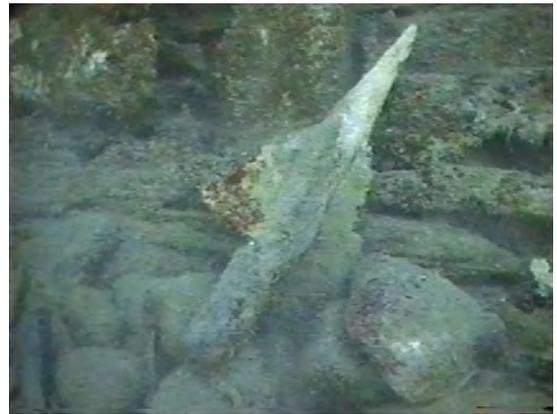
Figure 38. A nautical trailing log (the torpedo looking object). This was trailed behind the vessel and attached to a calibrated device that then measured hull speed.

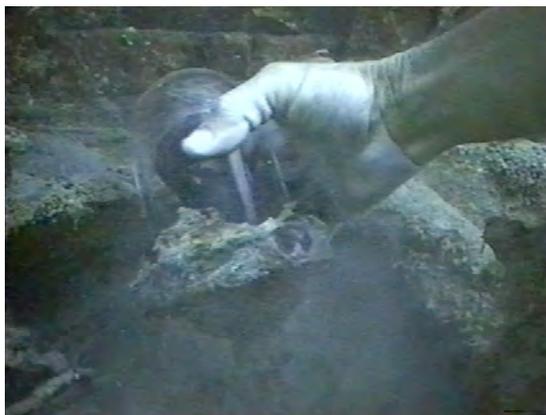
Figure 39. The sealed lamp was a fishing tool. Supplied by electricity for light, it was lowered into the shallows to lure baitfish to a net, or lowered deep to attract tuna to a nearby baited hook.

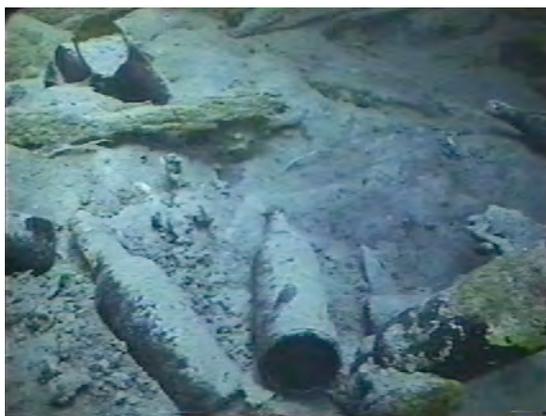
Figure 40. Many bottles litter the bottom. Most are labeled "Dai Nippon Brewery, Ltd.". Some are broken and offer danger to un-gloved fingers.

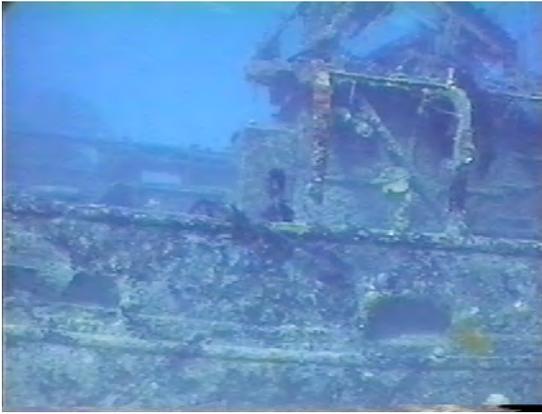
Figure 42. The forward deckhouse held a radio room, and the pilothouse above it had collapsed, revealing many other artifacts.

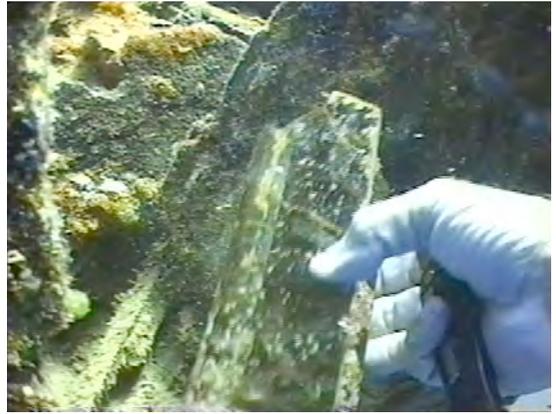
Figure 45. A broken glass prism found near the magnetic compass was probably mounted in the ceiling for additional natural light.

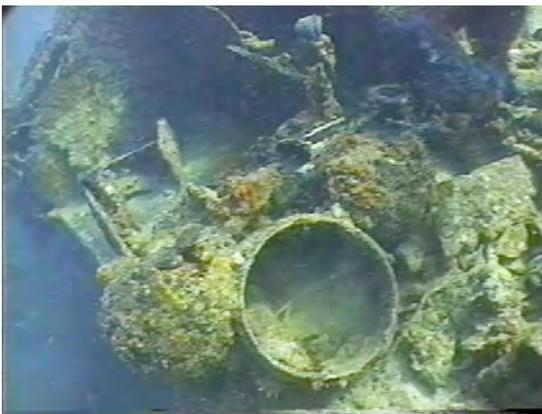
Figure 43. The magnetic compass housing was located on the starboard side of the pilothouse area. The compass is gone, removed or fallen out, but the side magnets remain.

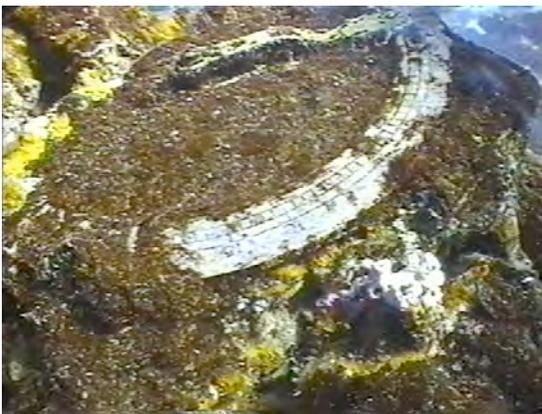
showed the vessel had a large oversized wheel, and it was additionally marked with degree points for navigation. A rudder angle indicator, which I had first thought was an inclinometer, was also within the collapsed pilothouse (Figure 44).

Figure 44. The rudder angle indicator fallen amongst the pilothouse debris.

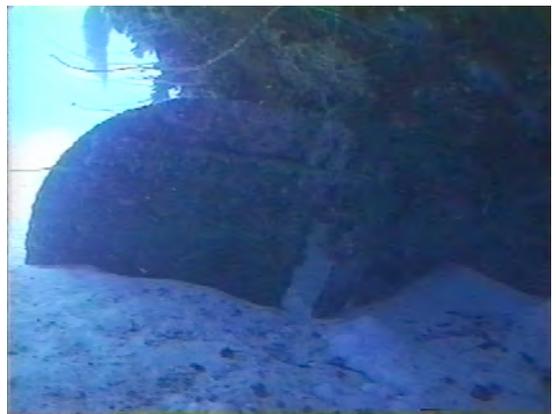
Figure 47. Rudder and propeller of the vessel are complete, and completely buried in the sand.

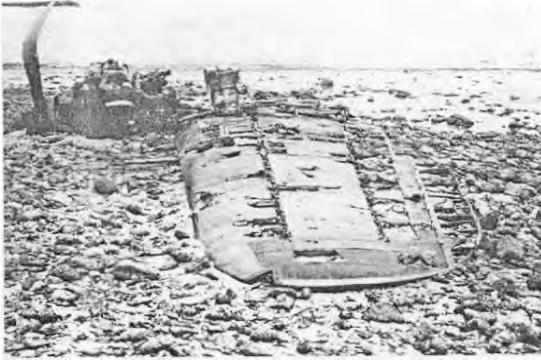
Figure 52. Photograph taken by Bartsch in 1986 of the Southern Ollet A6M "Zero". The forward panel with ejection chutes for the fuselage machine guns was still in place.

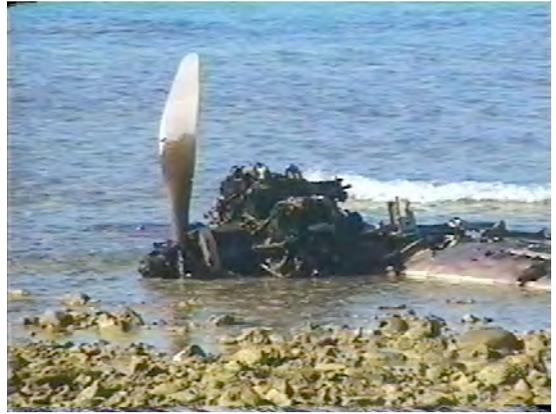
Figure 55. A photo of the site as the tide ebbs.

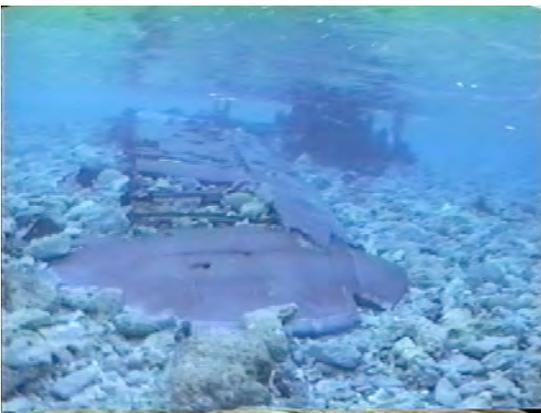
Figure 54. Higher tides cover all but the propeller tip. Fast and surging water makes photography difficult.

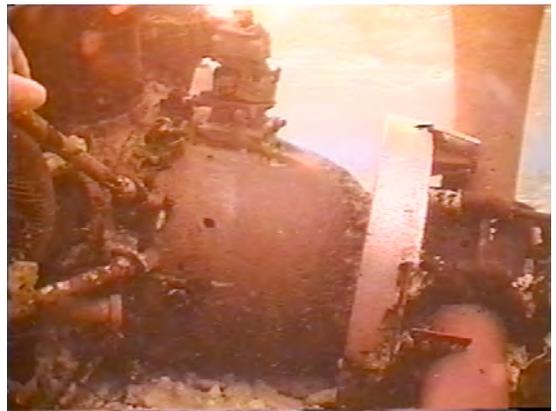
Figure 57. The close up photograph of the engine with propeller hub helps identify the aircraft model.

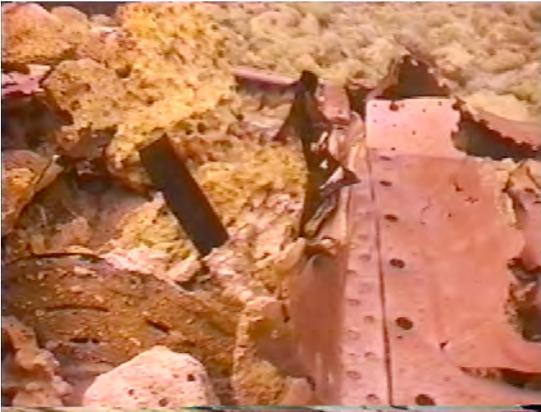
Figure 58. Photo of the 20mm cannon ammunition drum partially torn open with 20mm shells removed during one of the islands scrap drives for brass and copper.

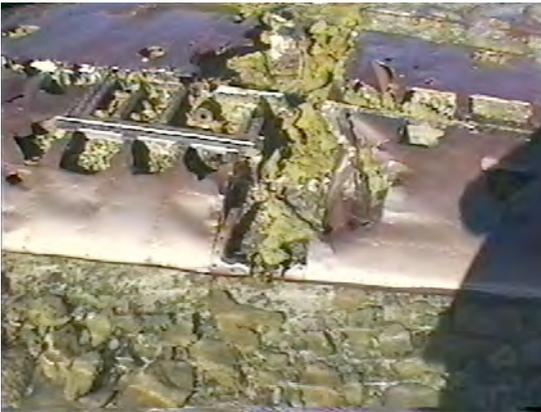
Figure 59. Cavity in left wing where 20mm cannon used to reside.

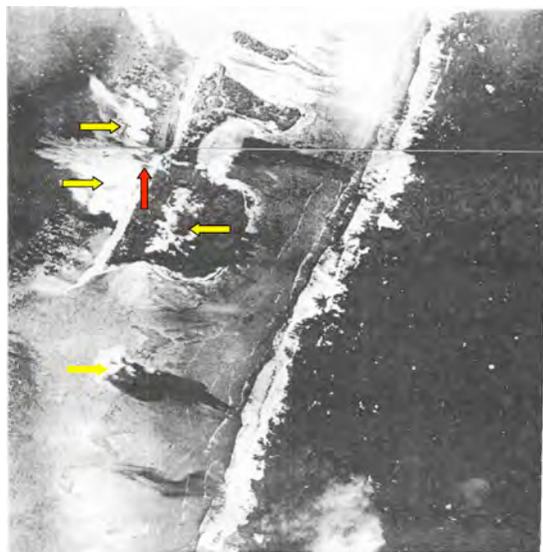
Figure 63. War-time image of Pigete Island after a bombing raid. The pier is identified by the vertical arrow, while horizontal arrows mark bomb hits.⁹

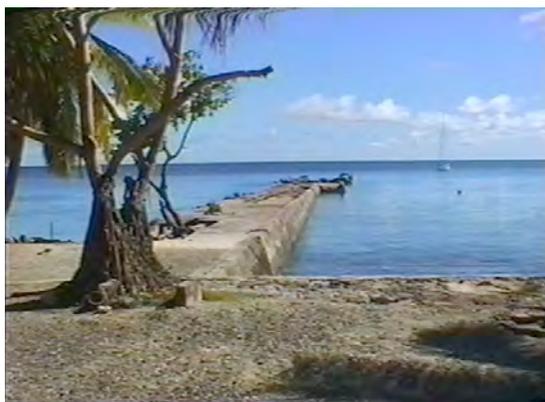
Figure 64. The Japanese Pier at Pigete stretches nearly 100 yards from the natural shoreline. The pipe trench, blown open farther down on the right side, held both water and fuel lines. An anti-aircraft position was set up on the right side end.

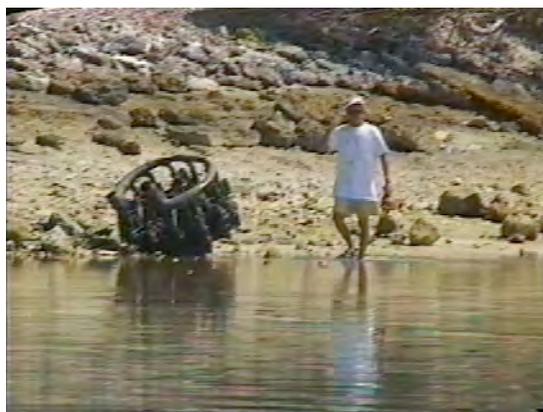
Figure 67. The author walks past the north B-25 engine near the shore of Chierumarokku Island at low tide.

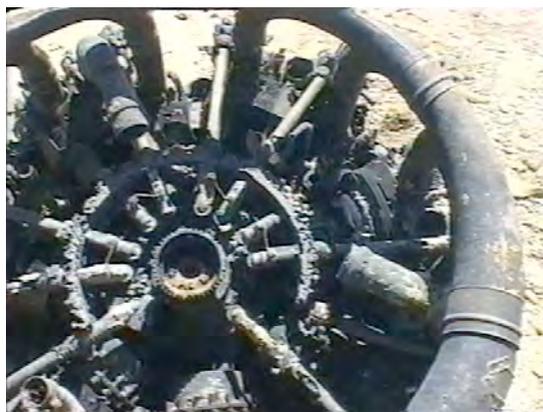
Figure 68. The close up view of the northern B-25 engine, with many parts, including the exhaust collector ring manifolds, still attached.

tifiable from their design and twin row 14-cylinder configuration. Figure 67 and Figure 68 show the north engine near the island, and a close up of the backside. A photo of the southern engine is reproduced as Figure 69, with the Figure 70 showing one of the many small parts found around the site. Both engines had been rolled on the reef for years by the wave action and were worn down to the cylinder heads and exhaust collector rings. No propellers or any other identifiable exterior portions of the engines were located.

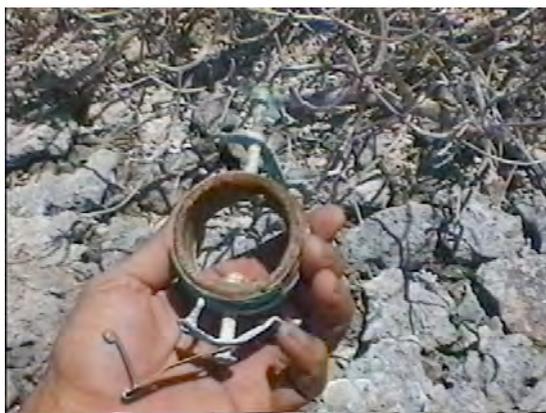
Figure 70. One of many small engine and aircraft parts found around the site. This is part of the carburetor.

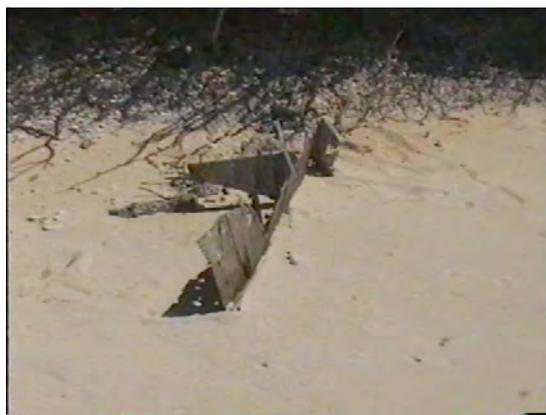
Figure 71. Photo of aluminum beach debris near the high water mark on the south side of the island.

Many many small aluminum parts and metal shards with assorted rusting fasteners were located on the reef and mixed within the beach rubble of Chierumarokku island (Figure 71 shows debris in the sand on the southern face of the island. Figure 72 shows the remains

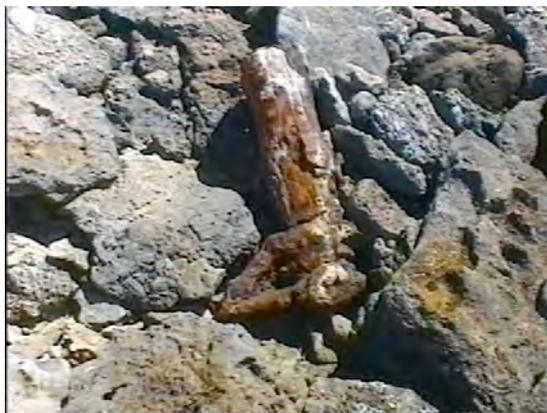
Figure 72. Part of the landing gear assembly sits amongst the coral rocks on the southeast side of the island

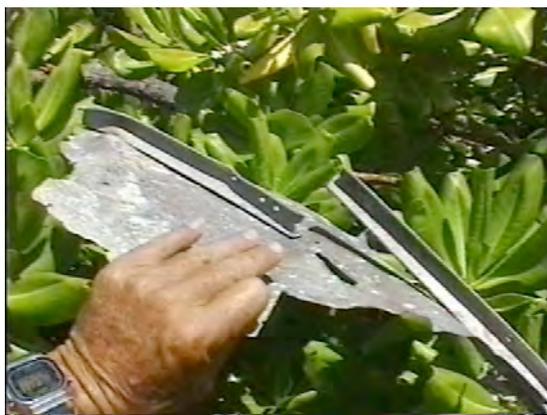
Figure 73. Aluminum debris was literally lying at the edge of the jungle on Chierumarokku Island.

of a landing gear within the coral rocks. Figure 73 shows parts literally removed from the jungle near the high water mark.

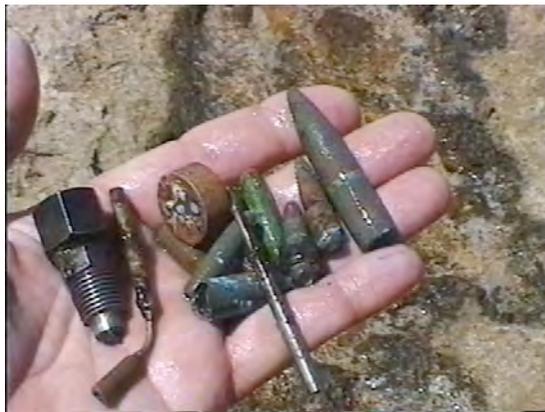
Figure 74. Beach objects collected near the north engine from pockets in the reef. Items include, from left to right, a hydraulic/pneumatic fitting, a brass rod, a stainless rod, a bronze engine injector part, and six brass bullets, either 5.62mm or 7.65mm Japanese rifle rounds, and one .50 caliber US machine gun round on the far right.

Mixed among the debris were numerous small caliber rifle rounds, as the Japanese used the island and/or this B-25 wreckage for target practice. Figure 74 shows a handful of assorted parts collected from pockets in the hard reef.

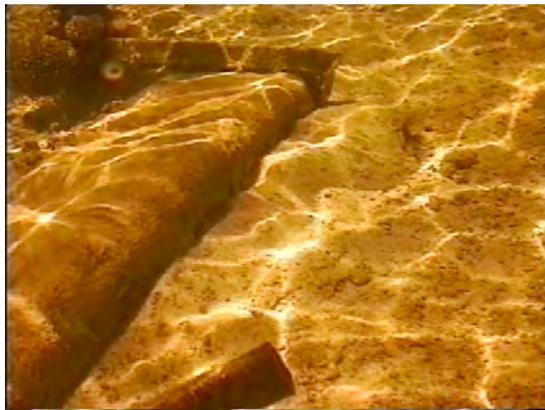
Figure 75. Underwater photo of a probable wing aileron section lying on the sand in shallow water south of the main debris site.

A part of the wing was discovered and photographed underwater (Figure 75), as was a section of probable fuselage framing (Figure 76). Both were closer to the lagoonside drop off.

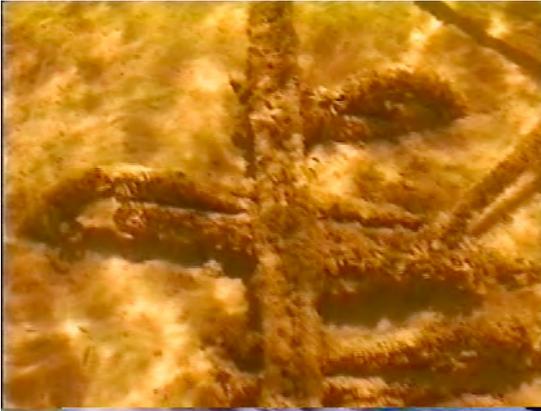
Figure 76. Aircraft frame sections underwater southwest of the island in the sand in shallow water.

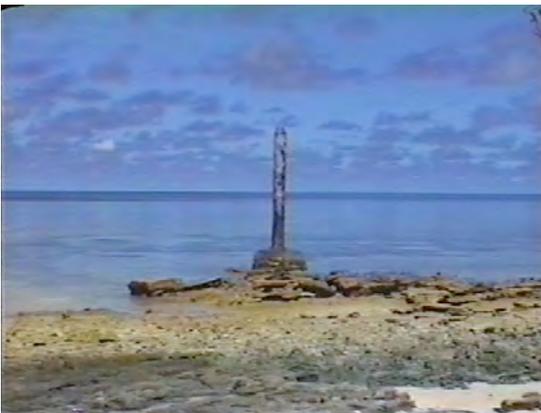
It is possible more aircraft parts are buried in the sand and may be discovered later or as the sands shift. Marine life nearby consists of yards of clean white sand with pockets of beautiful coral growth and local reef fish. The Japanese anchorage marker built before the war still stands on the lagoonside reef for reference (Figure 77).

Figure 77. Harbor anchorage marker listed on the map as a pillar near Chierumarokku Island still exists.

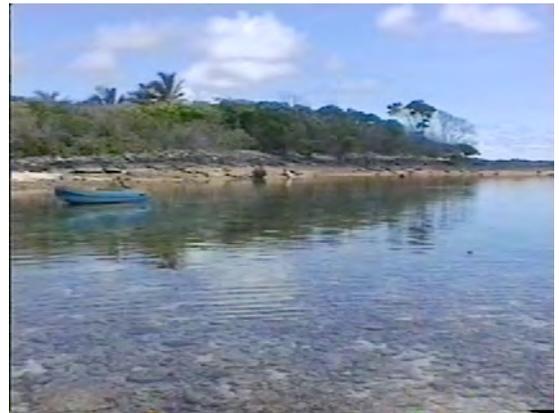
Figure 78 shows Chierumarokku Island. The island is very small, measuring little over 100 yards in diameter. There are no temporary or permanent houses or shelters on the island, which was a local bird hunting sanctuary island in 1981. It is a sad comment there are no birds on the island today. You may walk to the site from Taroa at low tide, but it is a long walk over rough terrain near the engines, usually under a very in a hot sun. Plan for two hours round trip, and take water!

Figure 78. Chierumarokku Island during an ebbing tide. Note the northern B-25 engine exposed in the distance, the darker object to the right of the inflatable boat.

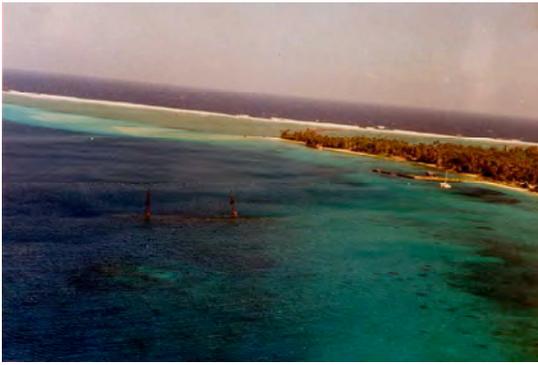
Figure 80. Aerial view showing the submerged Terushima Maru off Tarao.¹¹

The *Terushima Maru* was probably built in the late 1920's or early 1930's, and was listed as 3110 GRT by an unknown someone, with an estimated length of 300 feet and a beam of 30 feet. It probably had 15 feet of draft at the stern. I have no information on the builder, the owner or the operator. Believe me, I have looked. The vessel now sits in 20 to 35 feet of water, with the two main service masts above water (Figure 80, Figure 81).

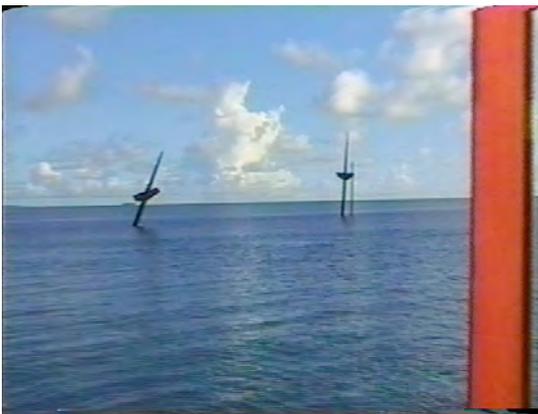
Figure 81. The two main service masts still stand after 60 years in the water.

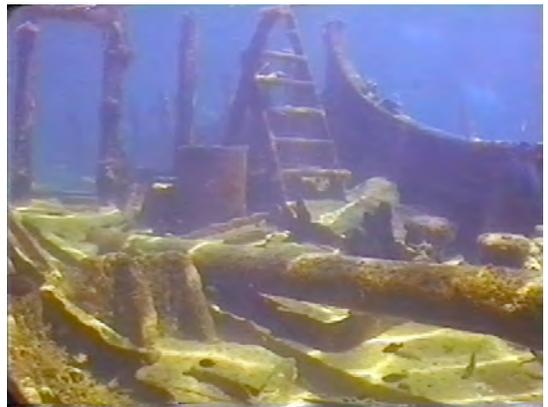
Figure 84. The area in front of the pilothouse starts to resemble a ship. The stairs have no place to go.

In any case, there is not much exciting to document in the bow. The next nice maritime view starts on the deck and in front of the pilothouse (Figure 83, Figure 84). The boiler can be seen through the missing pilothouse area in Figure 85. The small hold is visible in Figure 86.

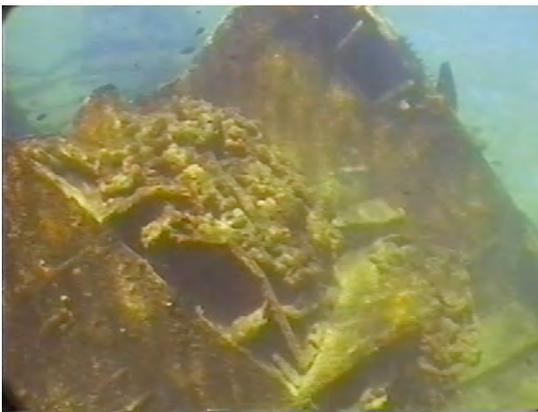
Figure 82. A large pile of chain near the chain locker is helping to crush the remaining bow sections into the sand.

The gun position was probably forward, more high and dry, which accounts for the mangled metal forward. Figure 82 shows a large pile of chain that was near its locker and now is crushing the remaining hull. But not all this damage is from the war. The Trust Territory demolition man, Mr. Steve Achen, deceased, blew the top off the vessel in the 70's. It is fortunate he did not set off the depth charges aboard. So it is very hard to determine what damage was caused from what. The 1945 photo in the USSBS report shows the vessel fairly intact.

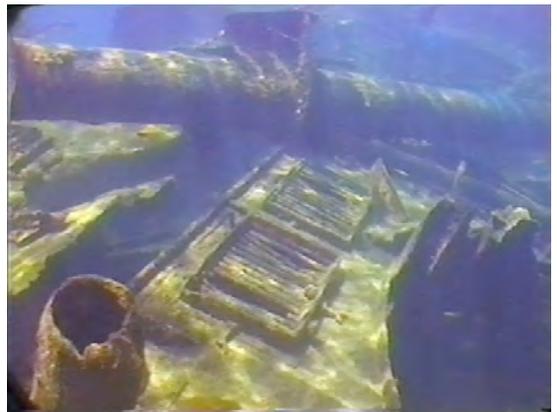
Figure 85. The area behind the pilothouse is open and exposes a large steam boiler.

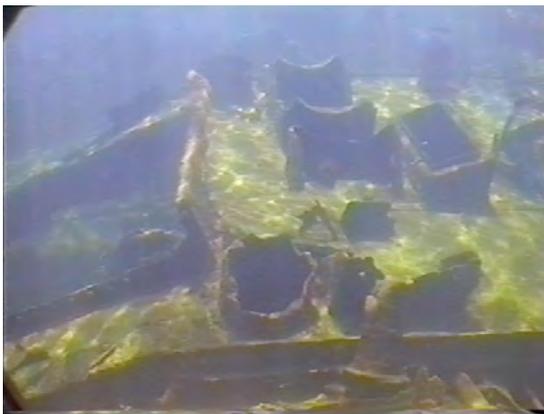
Figure 86. The area behind the boiler has the small working hold generally used for the vessel to carry fuel for the boiler.

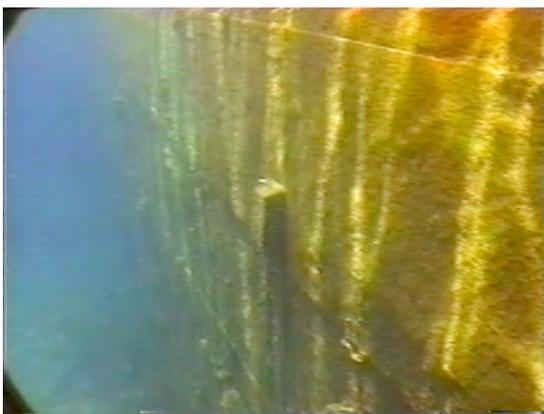
Figure 87. Clean hull forward of port side torpedo damage.

The torpedo analysis can be seen by comparing Figure 87 with Figure 88. The hull is very clean in the first photograph, taken a few feet in front of the second photograph location, which shows the heavy bending of the hull plate.

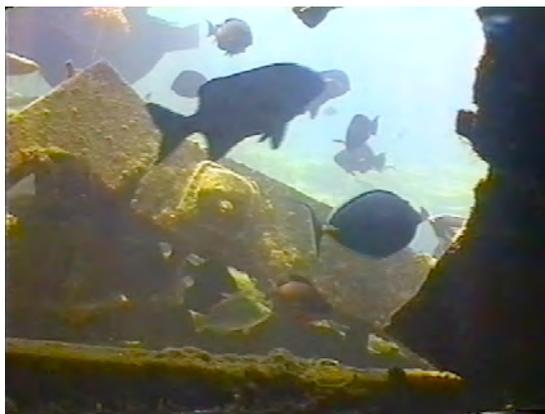
Figure 90. Abundance of marine life inside the wreck! Inside the hold near the demon crack area, starboard side.

There are many fish around this vessel and more inside too (Figure 90). Depth charges also exist (Figure 92). Depth charges are one of the few dangerous items remaining from World War Two. Many Japanese warships, when sunk, carried their live depth charges with them. If pre-set to 33 feet, as was a custom, and the safety forks fell off, they detonated. Many men were killed in the water in this manner. The depth of the hold is about 35 feet deep. The depth charges sit on a mid-deck, at about 20 feet down. If they were to roll off, or the deck deteriorates and fails, they are bound to detonate. Moving these depth charges is dangerous; blowing them in place would destroy the ship and this site. No easy answers.

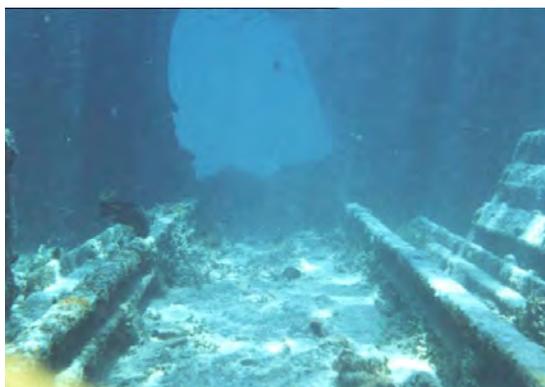
Figure 91. The depth charges were rolled down these railroad style tracks and off the stern into the deep to foil attacks by submarines. This track ran down the port side next to the last hold.

The depth charges were run down a track (Figure 91) and then off the back of the vessel (Figure 93). They had a safety diaphragm that was covered with a fork like safety device. This fork was pulled off by a mechanical "finger or hook" at the end of the tracks, arming the depth charge. The safety forks were made of wood and metal, and have long since corroded away.

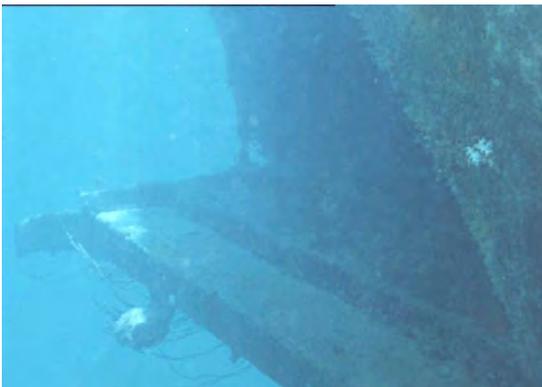
Figure 93. The depth charge track on the starboard side where it exits the stern.

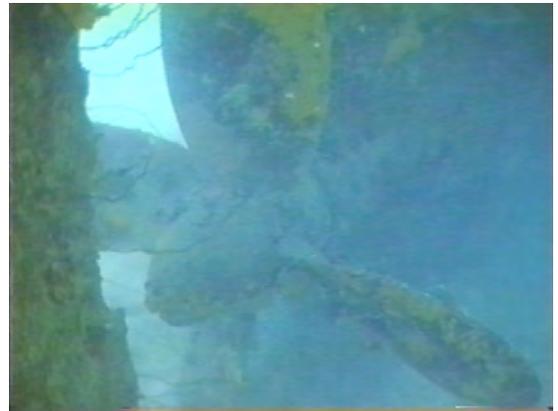
A view of the massive propeller is the final photograph (Figure 95). There were no significant artifacts anywhere in or around the vessel, hardly a broken bottle. The site is great for marine life photography, and fun for the SCUBA visitor, but again, be careful.

Figure 95. A massive propeller drove the ship. The propeller is complete, but with no identifying marks.
