Kariotis, John (1998 [2004]) 'The tendency to demolish repairable structures in the name of 'life safety'', in *Disaster Management Programs for Historic Sites*, eds Dirk H. R. Spennemann & David W. Look. San Francisco and Albany: Association for Preservation Technology (Western Chapter) and The Johnstone Centre, Charles Sturt University. Pp. 55-60.

The tendency to demolish repairable structures in the name of 'life safety'

JOHN KARIOTIS[‡]

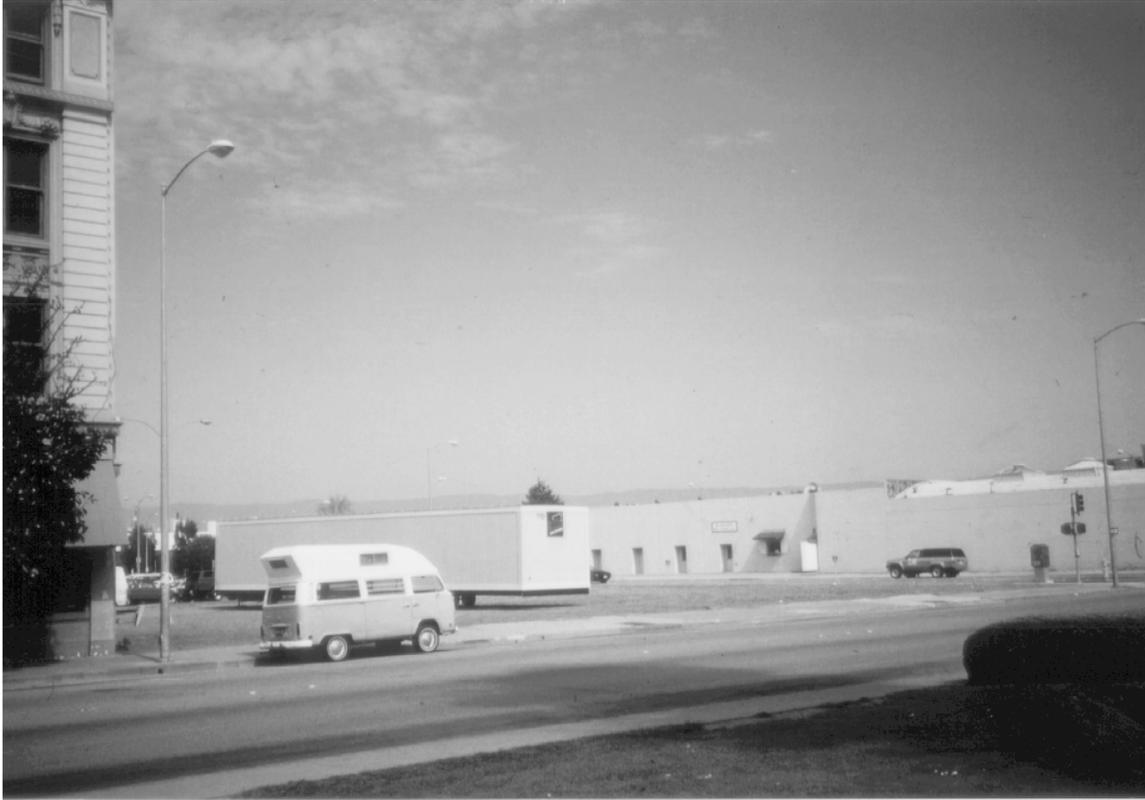
Figure 10.1. Site of the former Oddfellows Hall, Watsonville, CA. The building was damaged during the Loma Prieta Earthquake and was demolished even though it would have been repairable. Two years later the site remains vacant, a typical situation where local economies and lack of funding prevented a quick recovery and new construction to replace demolished retail buildings. (Photo: Steade Craig 1991).

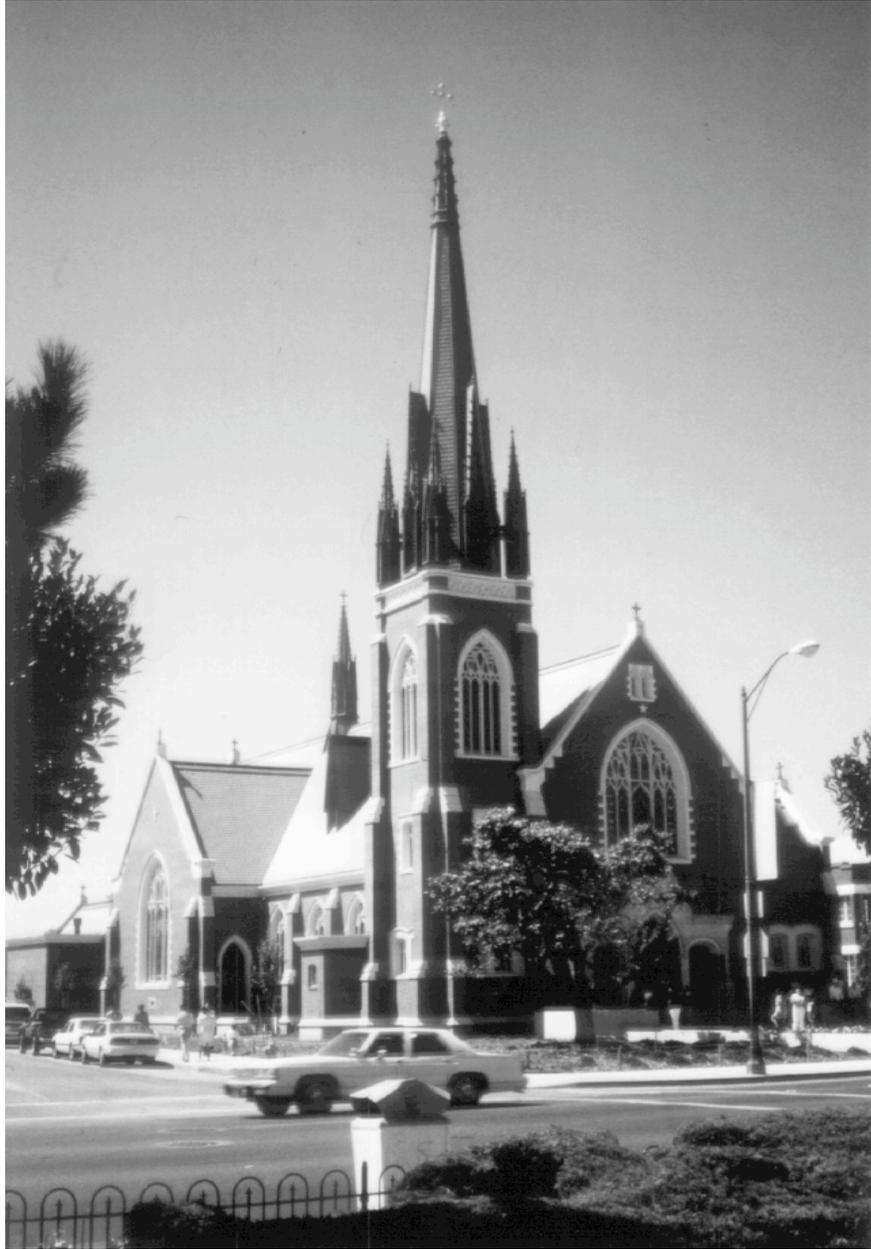
Figure 10.2. St. Patrick's Catholic Church, Watsonville, CA. The church was partially damaged during Loma Prieta in 1989. Because the congregation could not afford the necessary repairs and seismic retrofit the church was demolished and a new church constructed on the same site. The metal steeple was removed first because emergency officials feared the structure would topple in aftershocks, blocking a nearby main traffic route. (Photo: Steade Craigo 1989).
